What Parts of a Roof Usually Fail First?

An Architectural Field Guide to Roof Aging and Maintenance.

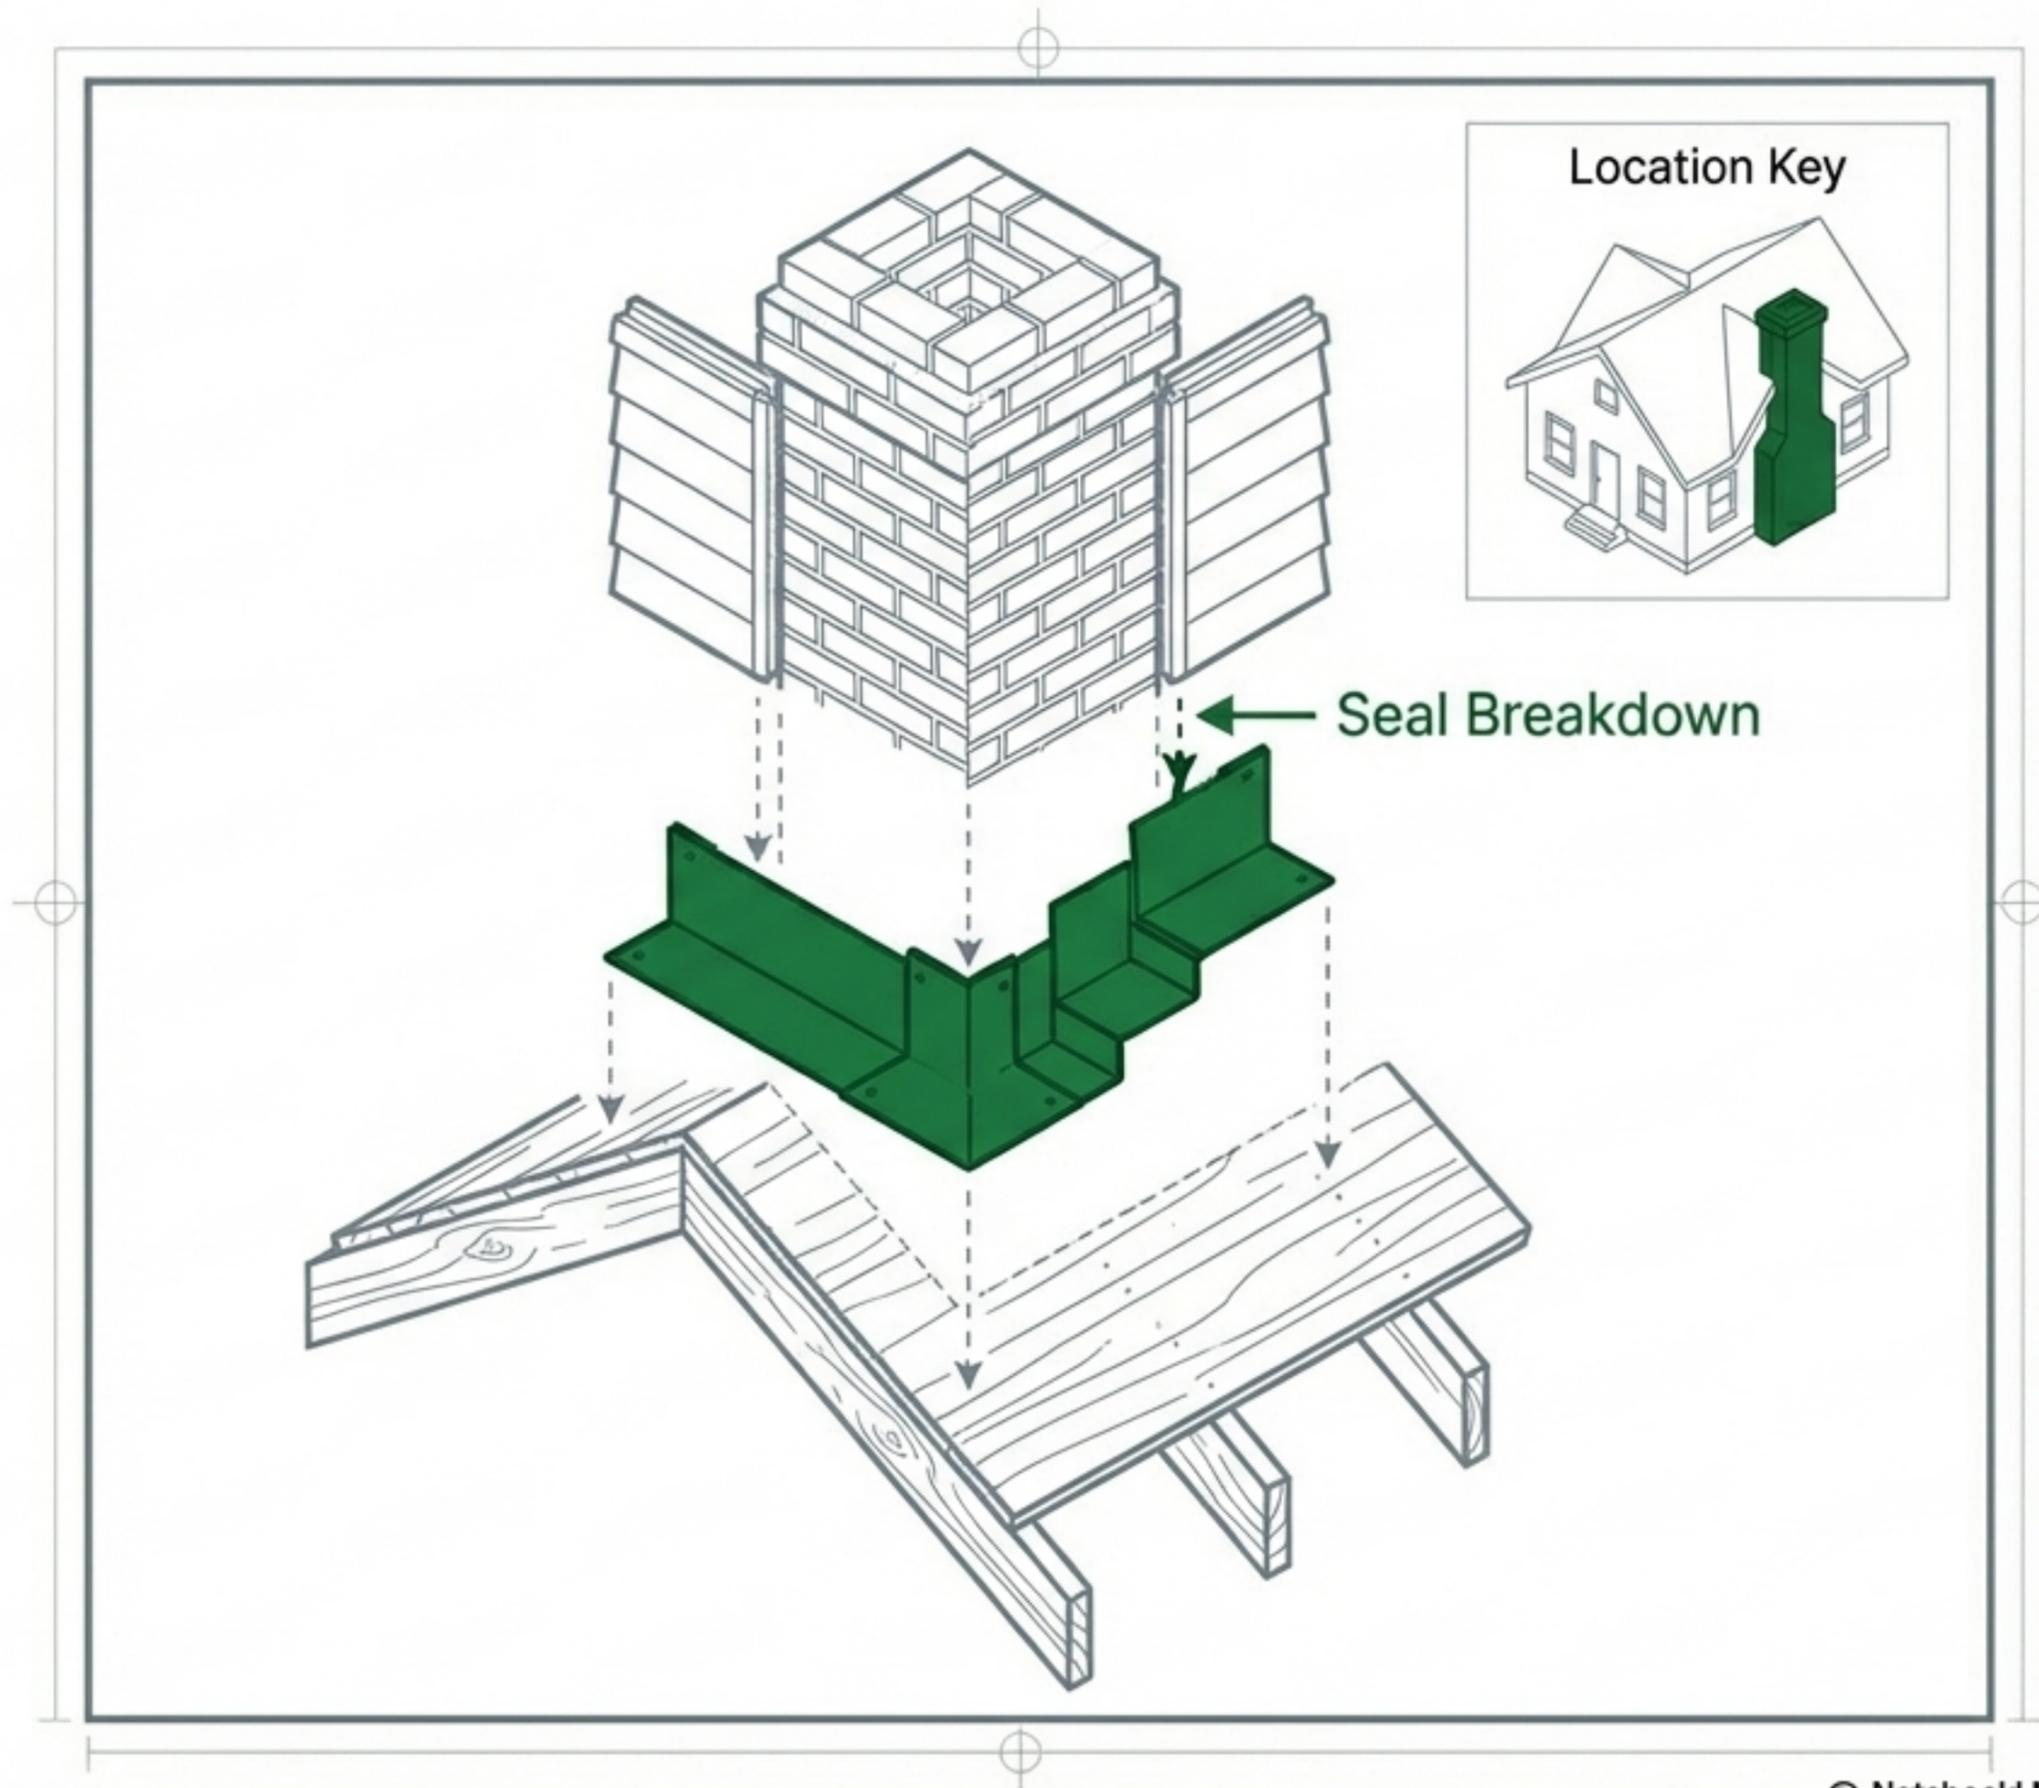
Flashing (Most Common First Failure)

- Metal step and base flashing bridge the critical gaps where the roof meets vertical walls or chimneys.
- Sealants and mortar joints meant to protect these transitions dry, shrink, and break down over time.
- Structural movement over time causes metal pieces to shift, opening direct pathways for water.
- Older galvanized steel components eventually exhaust their corrosion resistance.

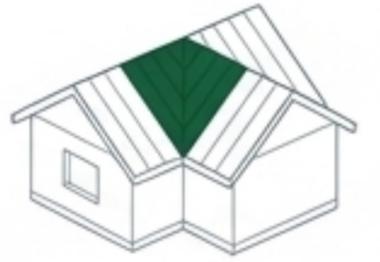
Location Key

Roof Valleys

- Valleys form the primary drainage channels where two sloping roof planes intersect.
- Heavy water flow is aggressively concentrated into these specific structural seams during every rain event.
- This concentrated volume accelerates faster wear, causing early granule loss on shingles or rust on metal liners.

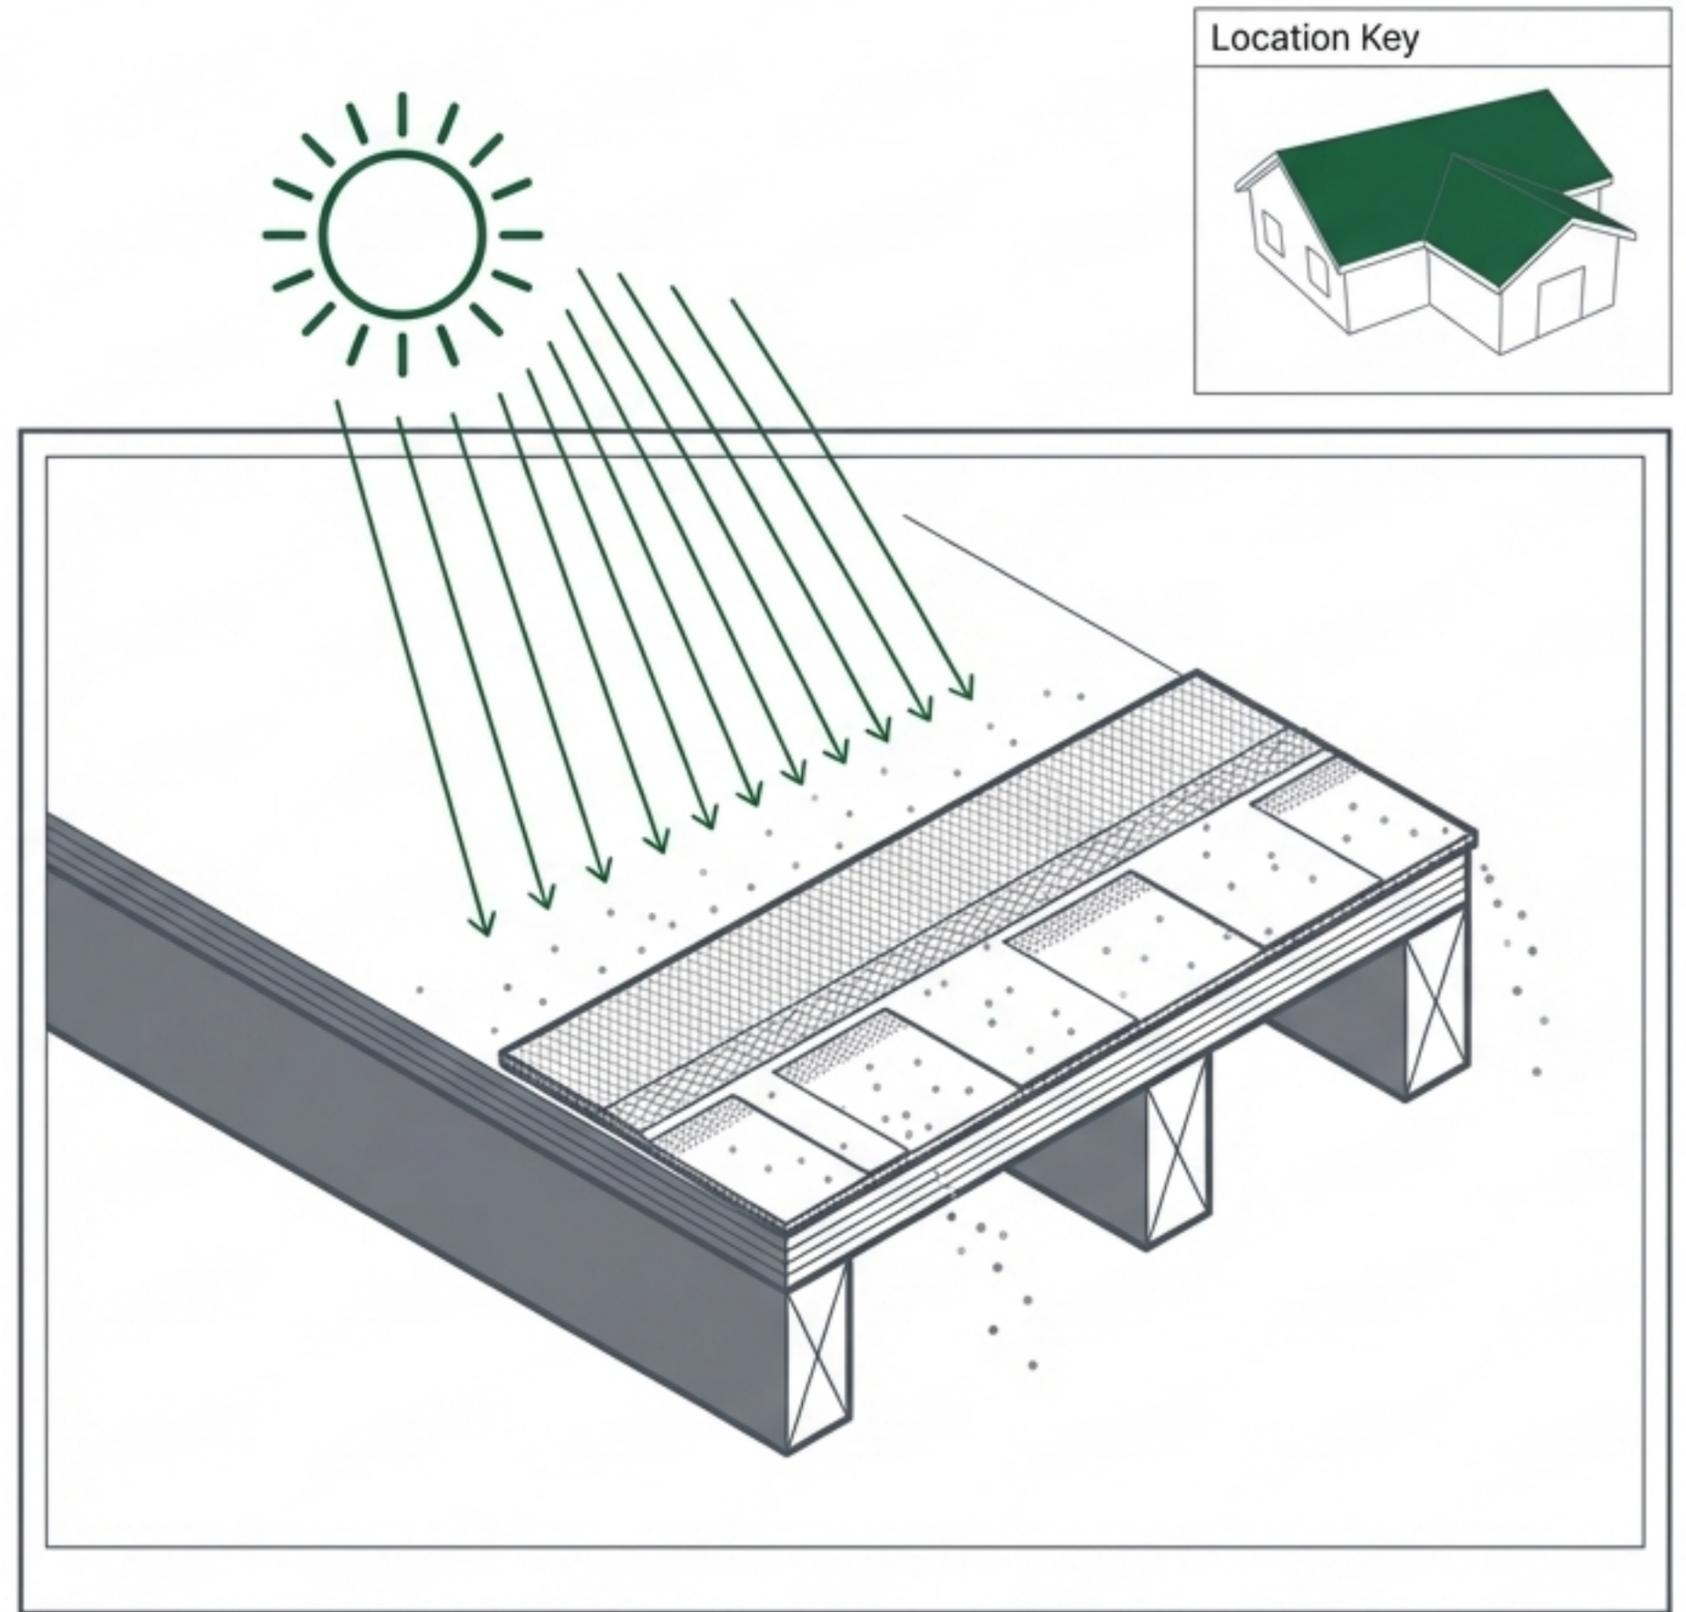
The Shingle Field

- Designed as a uniform, flat expanse to handle primary UV exposure and direct weather.
- Normal aging results in gradual granule loss and a slow reduction in flexibility over decades.
- Because they sit flat and avoid structural stress points, field shingles are usually the last components to actively fail.

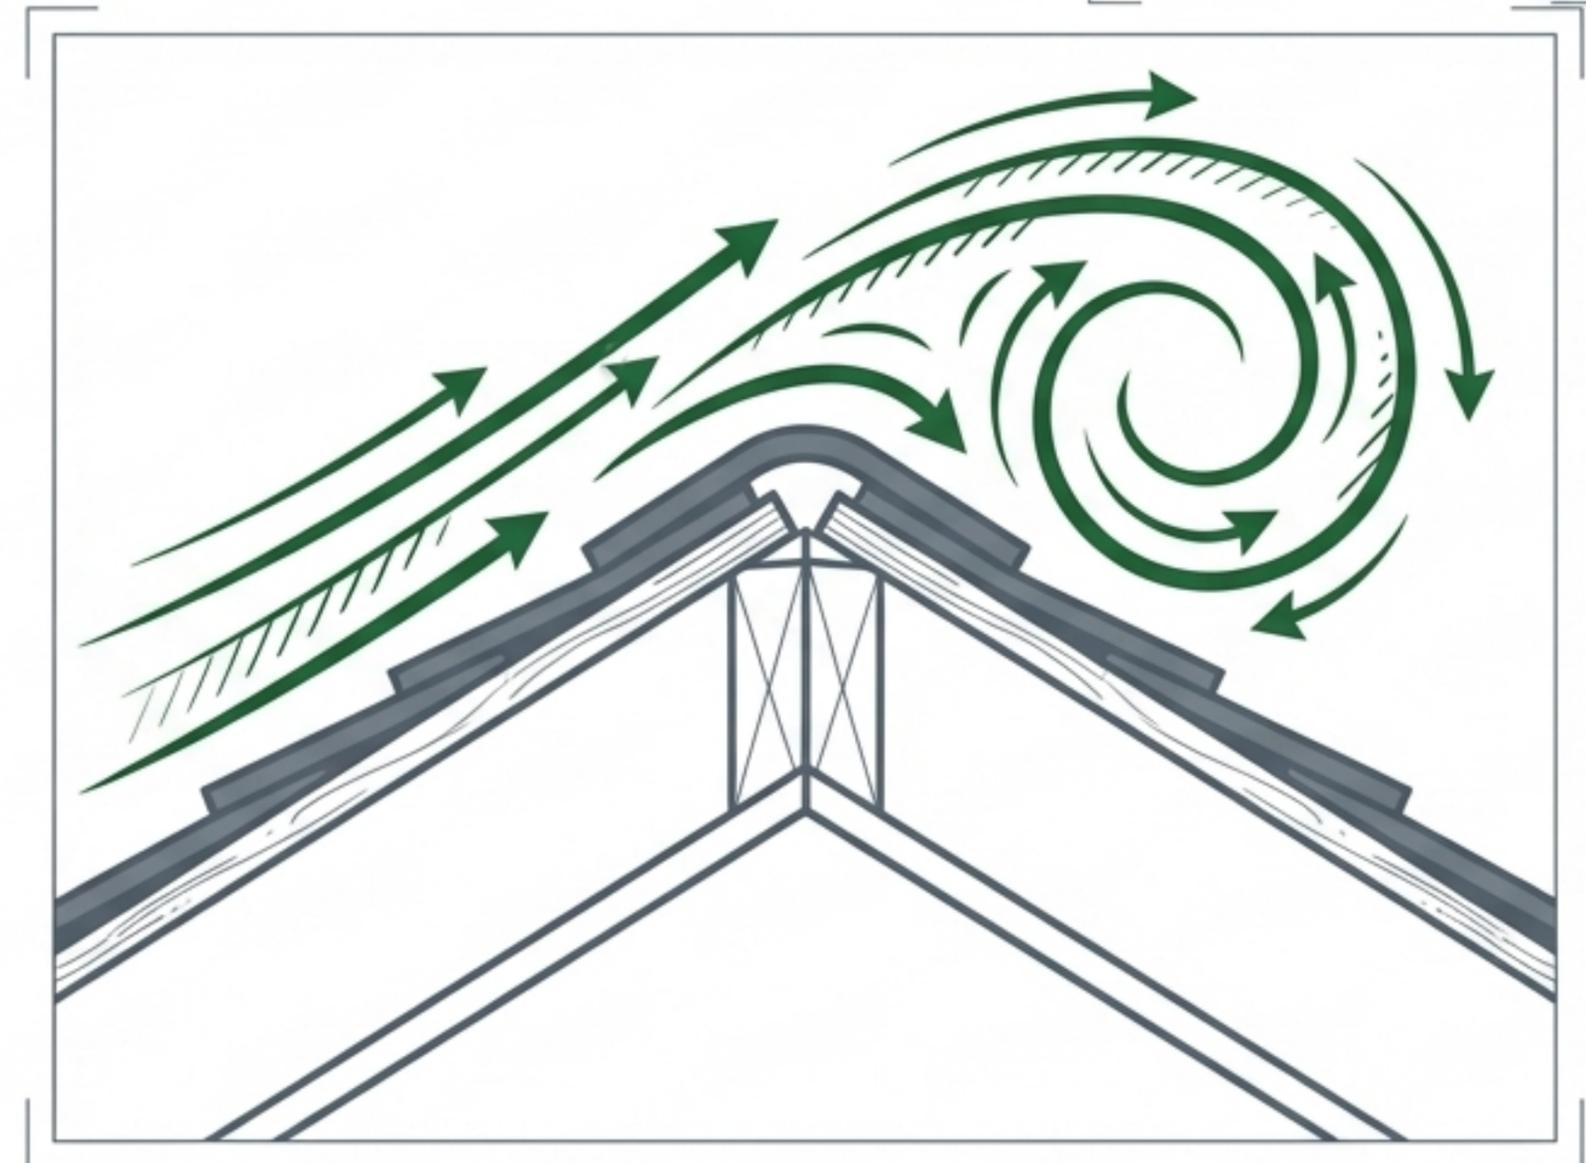
Ridge Areas

- Ridge cap shingles are physically bent to straddle the apex, maintaining constant structural tension.
- Maximum wind exposure creates aerodynamic lift, eventually cracking aged materials or dislodging caps entirely.
- Extreme temperature changes at the roof's highest point accelerate the loss of shingle flexibility.

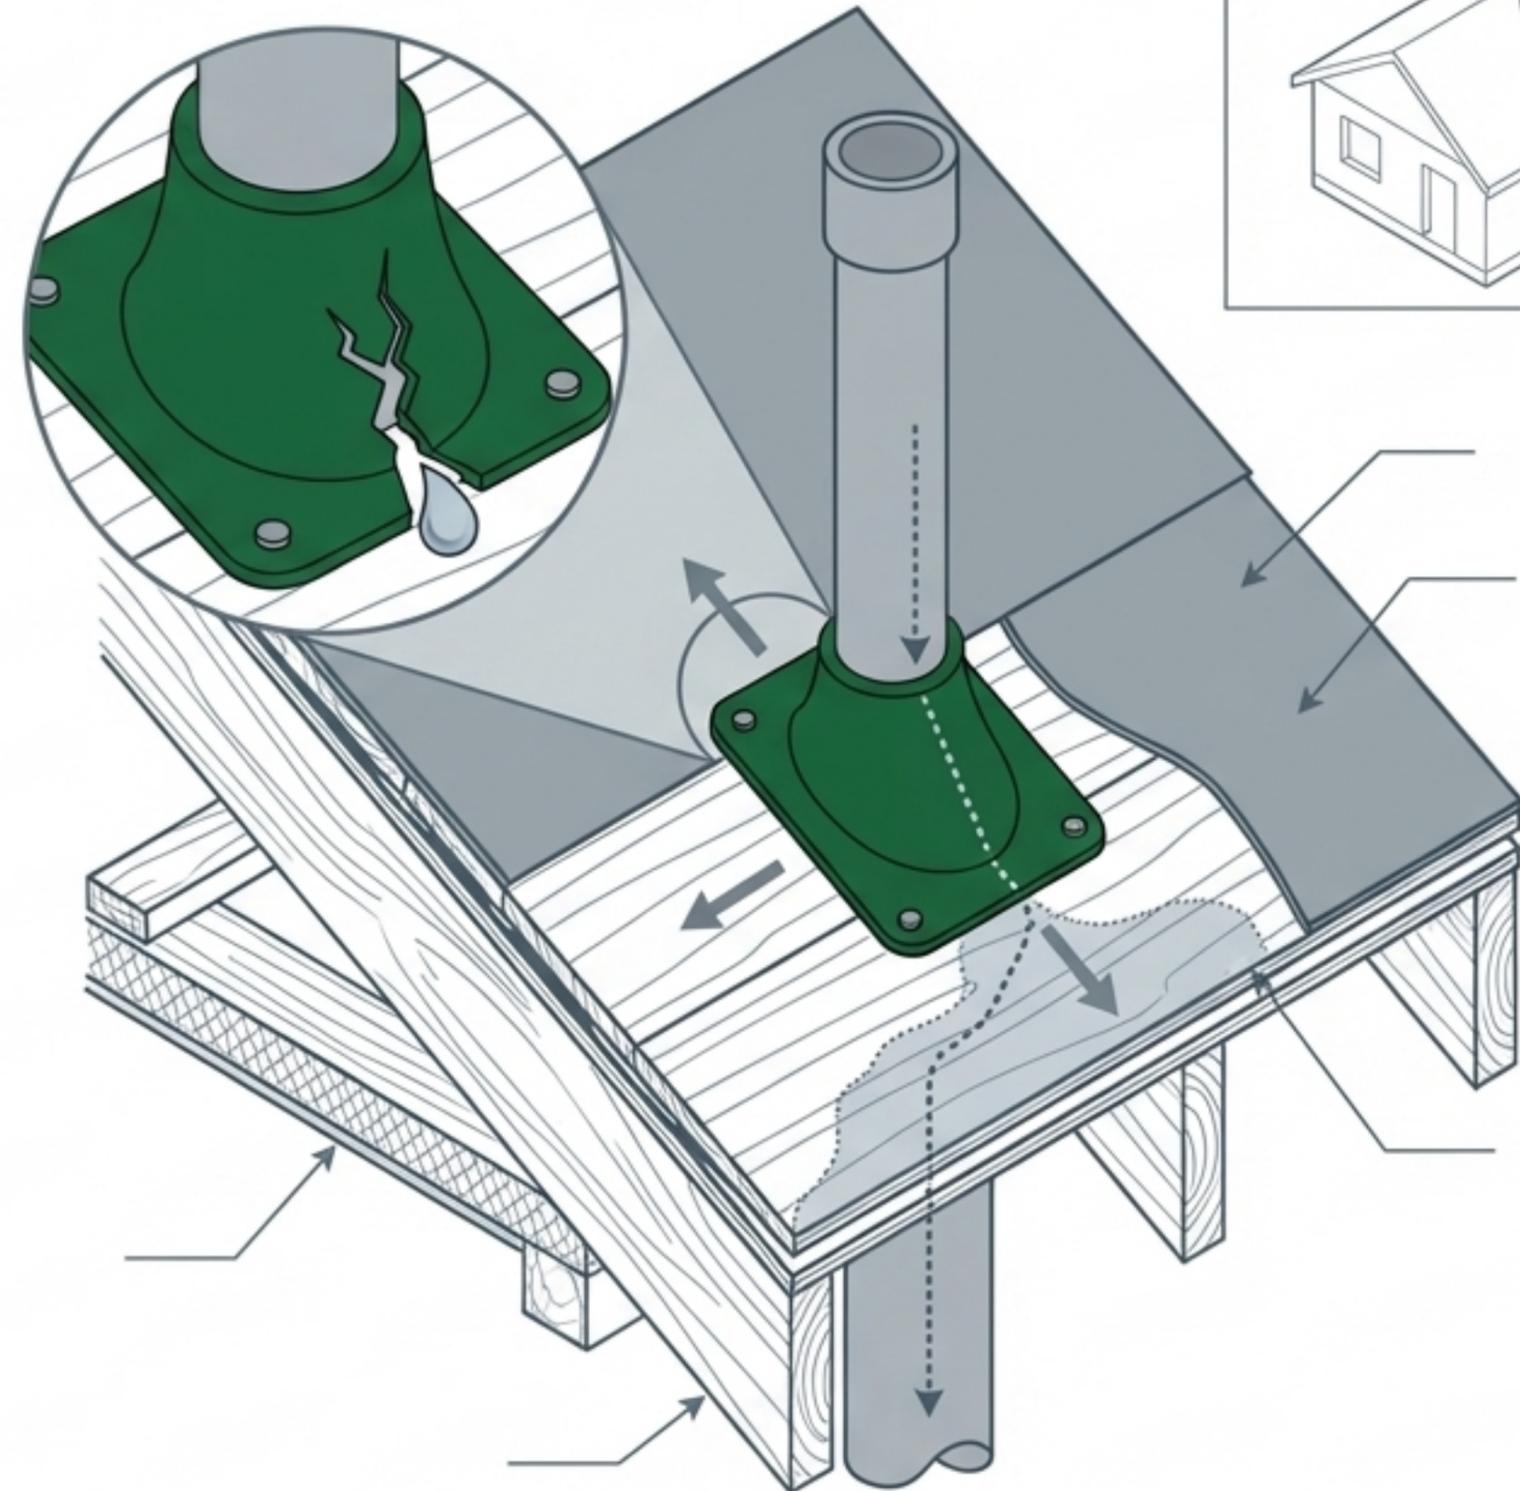
Ventilation & Penetration Seals

- Rubber pipe boots sealing plumbing vents have a maximum lifespan of 10–15 years—much shorter than the roof itself.
- Internal attic heat buildup bakes sealants and rubber collars from the inside out, causing them to split and crack.
- Failed seals allow hidden moisture problems, as water travels down the pipe and along decking before entering the home.

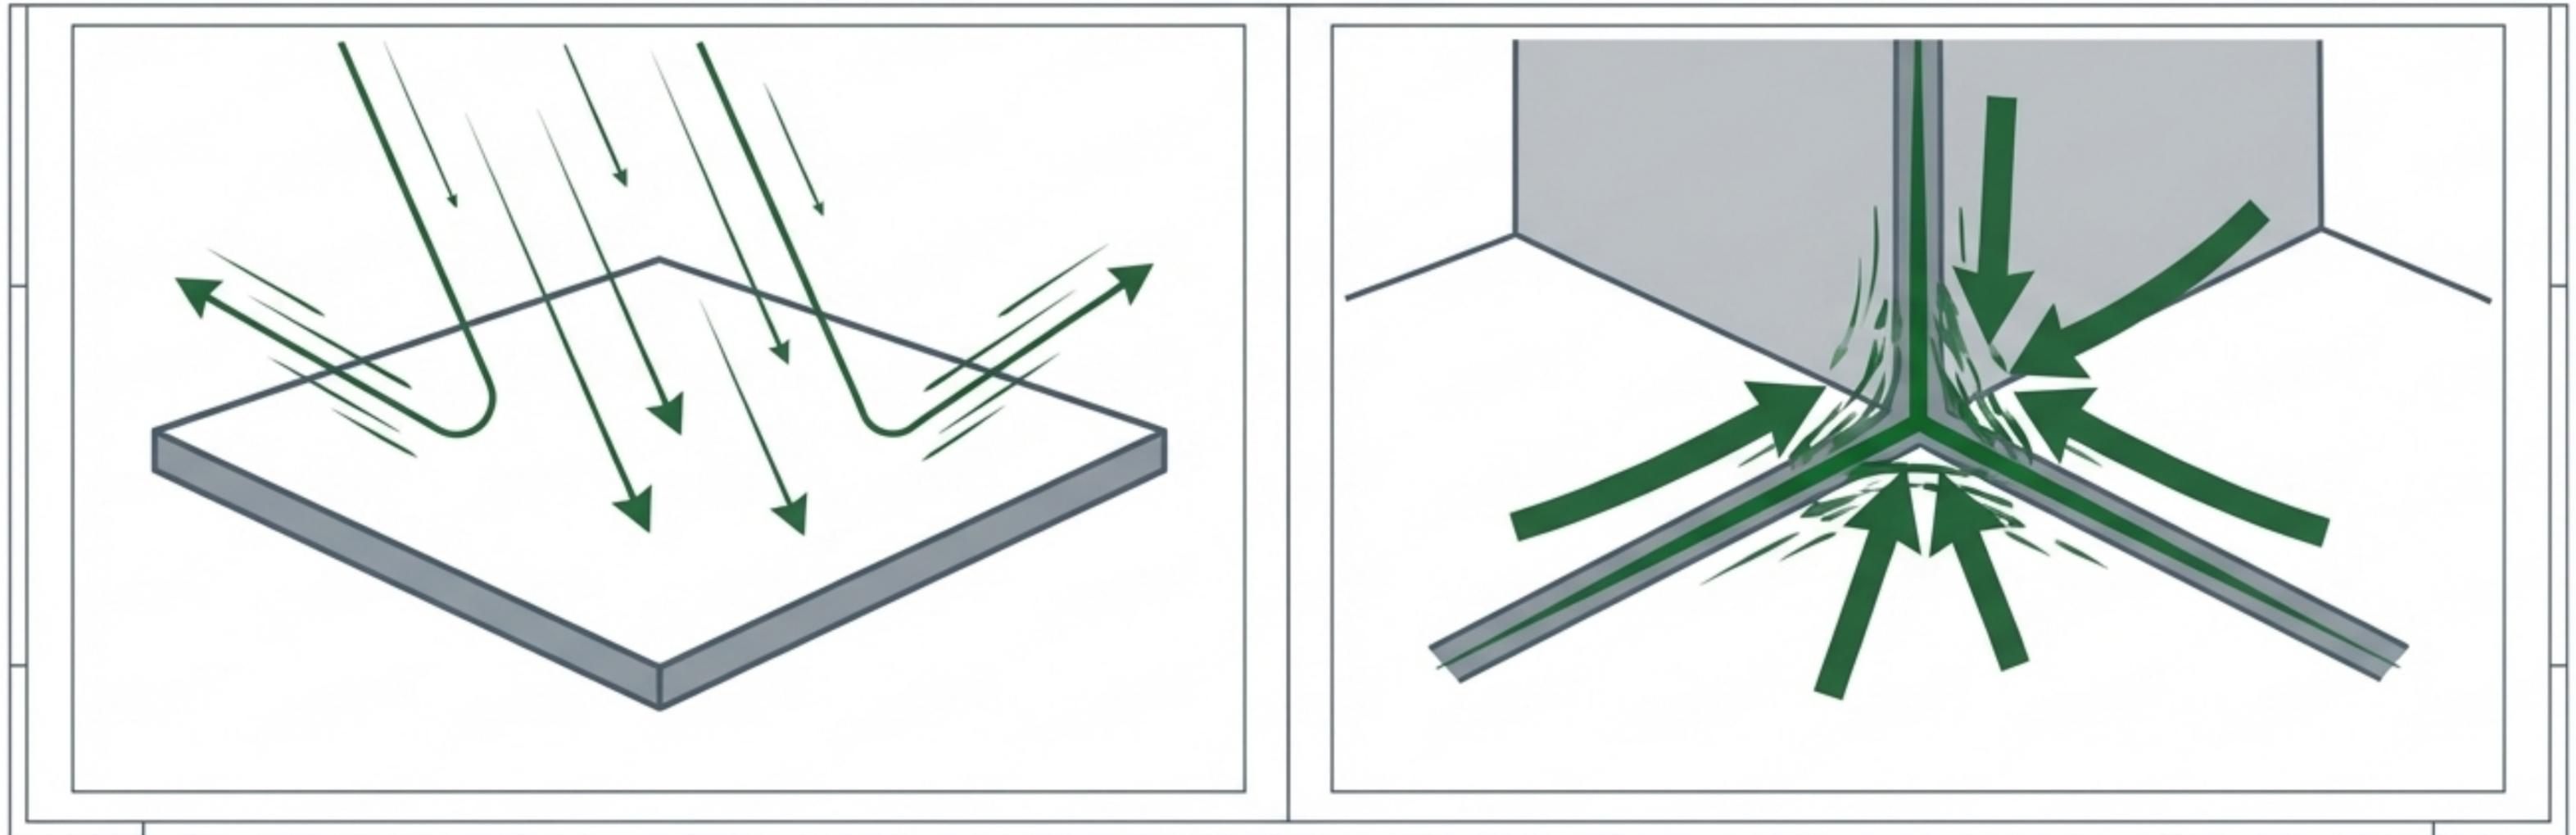
Stress Model

- Building systems follow a universal rule: joints fail before flat surfaces.
- Thermal expansion naturally pulls at seams, tearing sealants apart while leaving flat planes untouched.

Surfaces: Uniform stress shedding

Joints: Concentrated force & movement

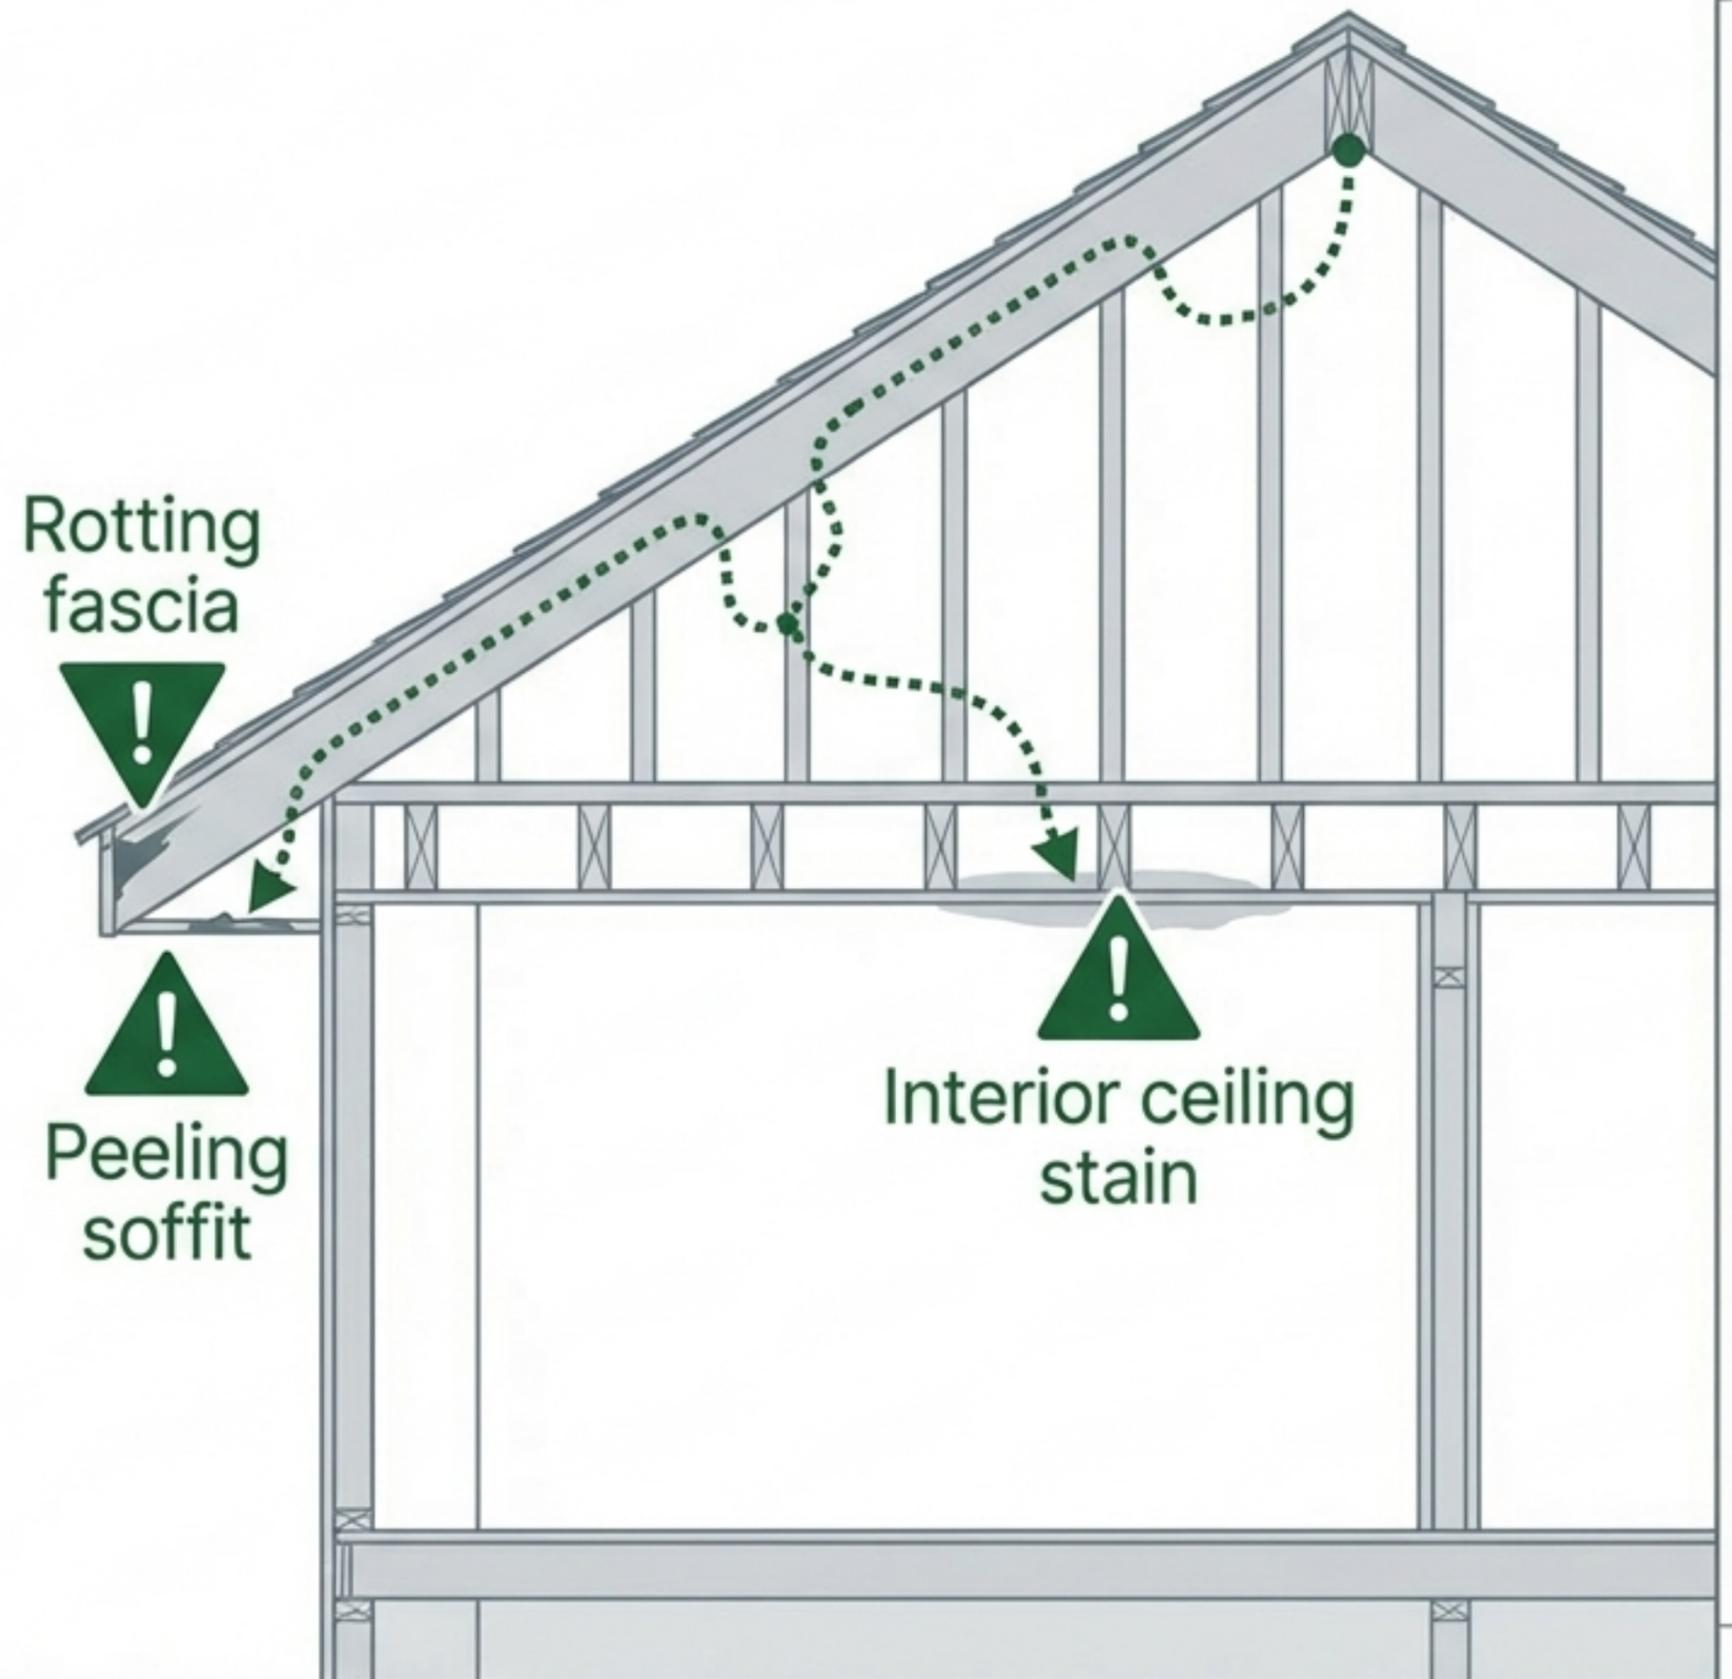
Early Warning Signs

- Rotting fascia boards or peeling soffit panels often indicate failed edge metal (drip edge) rather than gutter issues.
- Water travels along structural beams; indoor ceiling stains frequently appear several feet away from the actual roof leak.
- Visible gaps in sealant around chimneys or cracked rubber collars on roof pipes are guaranteed precursors to internal leaks.
