What Is Roof Flashing?

Understanding Function, Failure, and Prevention

An Educational Guide to Roof System Transitions

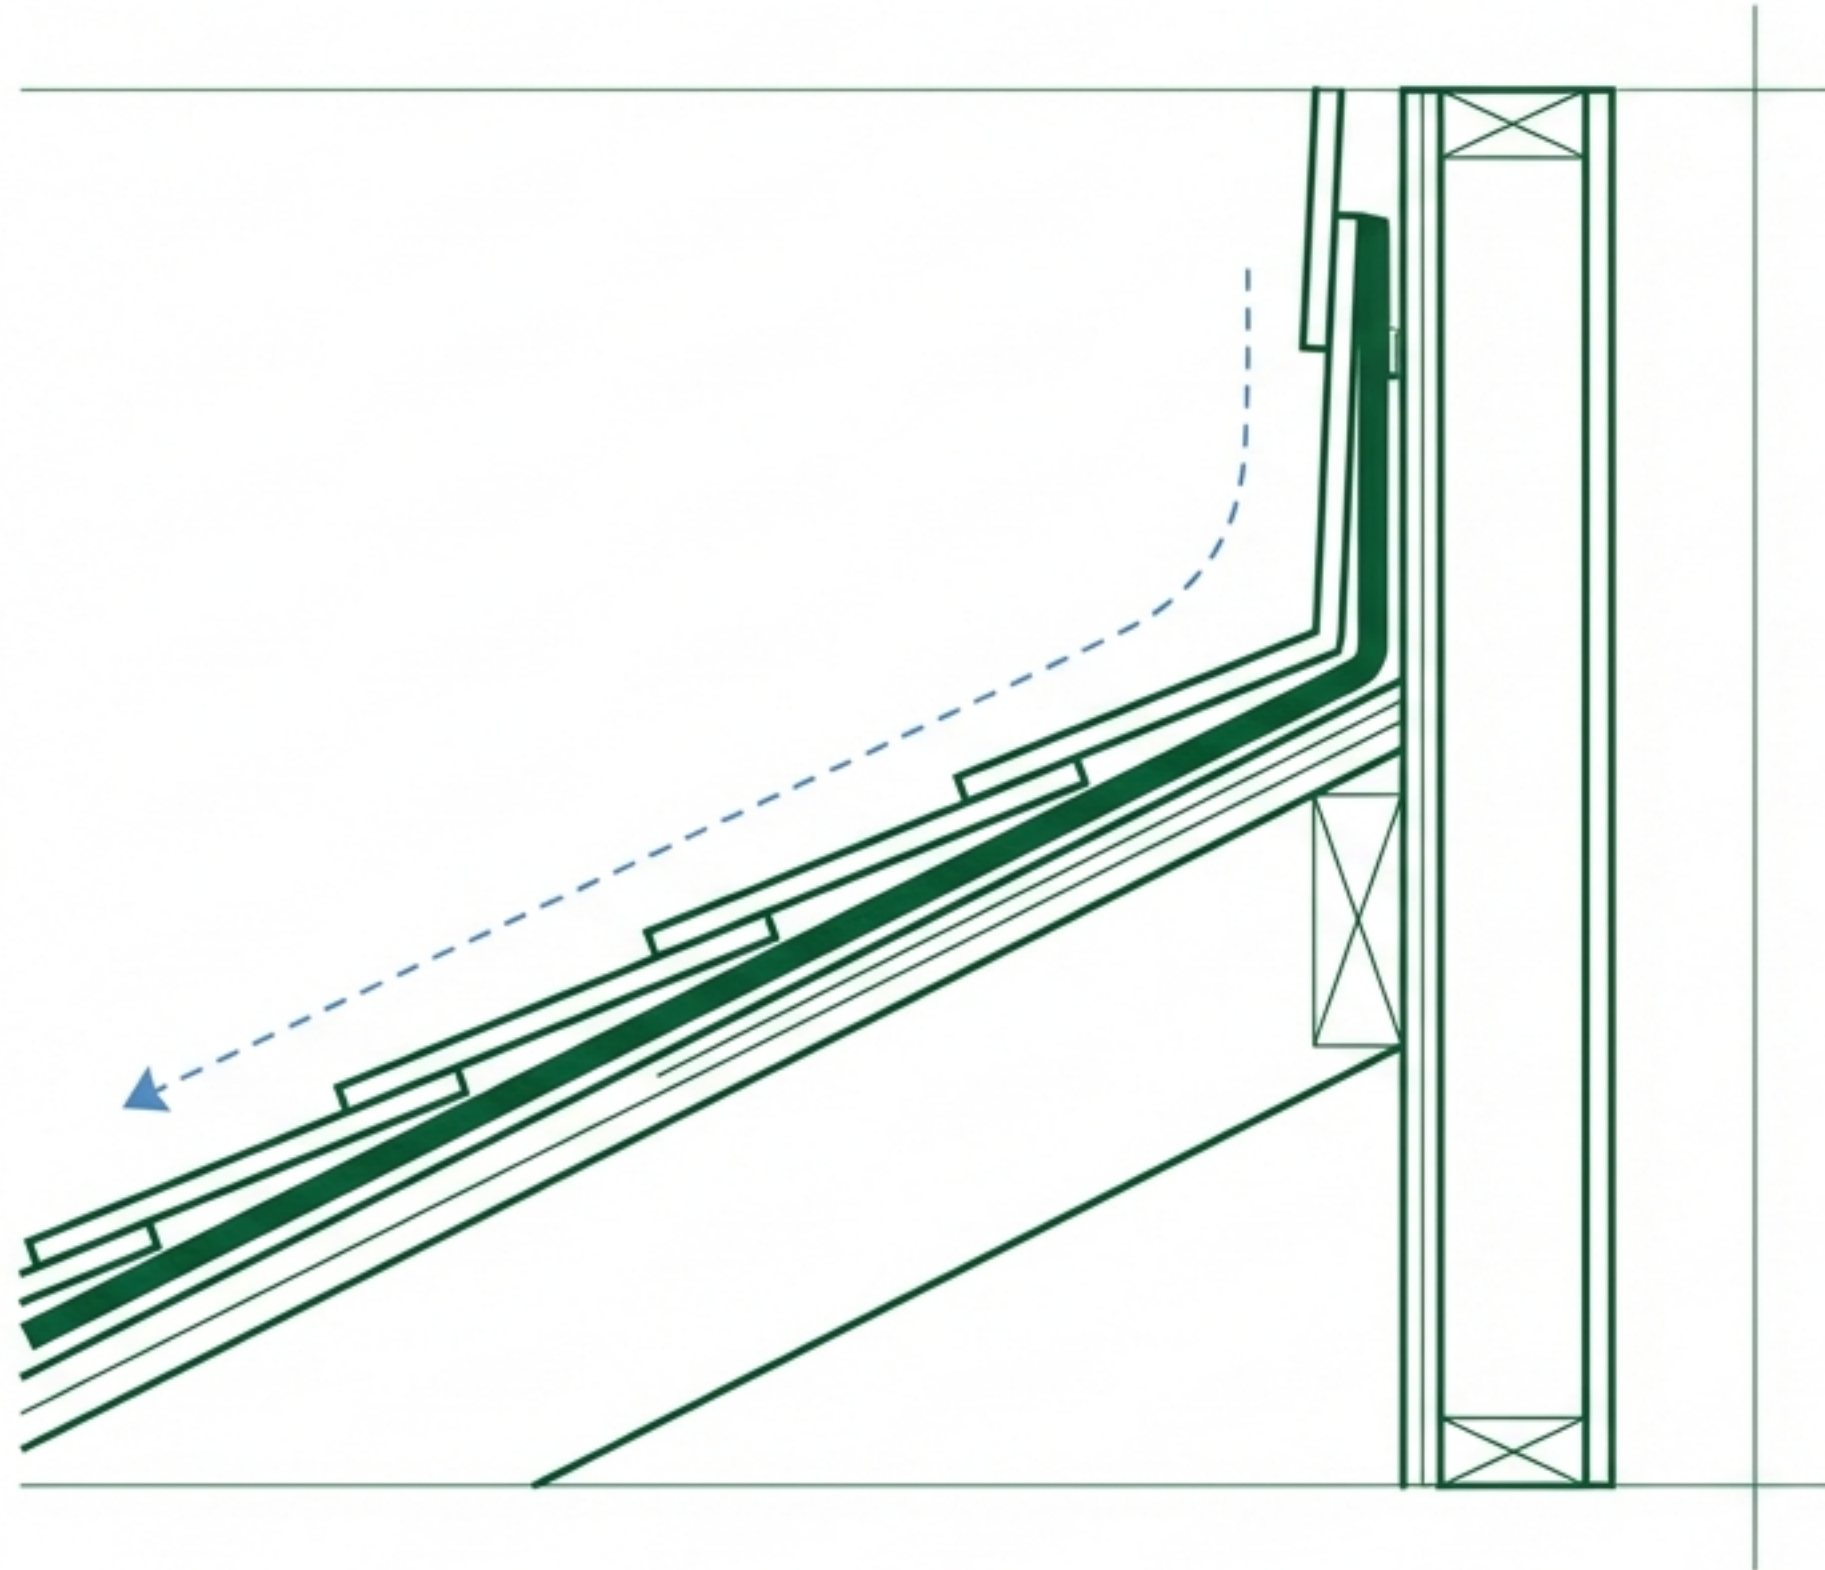
Purpose-built metal (aluminum, galvanized steel, or copper) bridging gaps in a roofing system.

Seals joints, transitions, and penetrations across the roof surface.

Protects areas where shingles alone cannot form a reliable, continuous barrier.

Channels water safely away from vulnerable joints and back onto the primary roof plane.

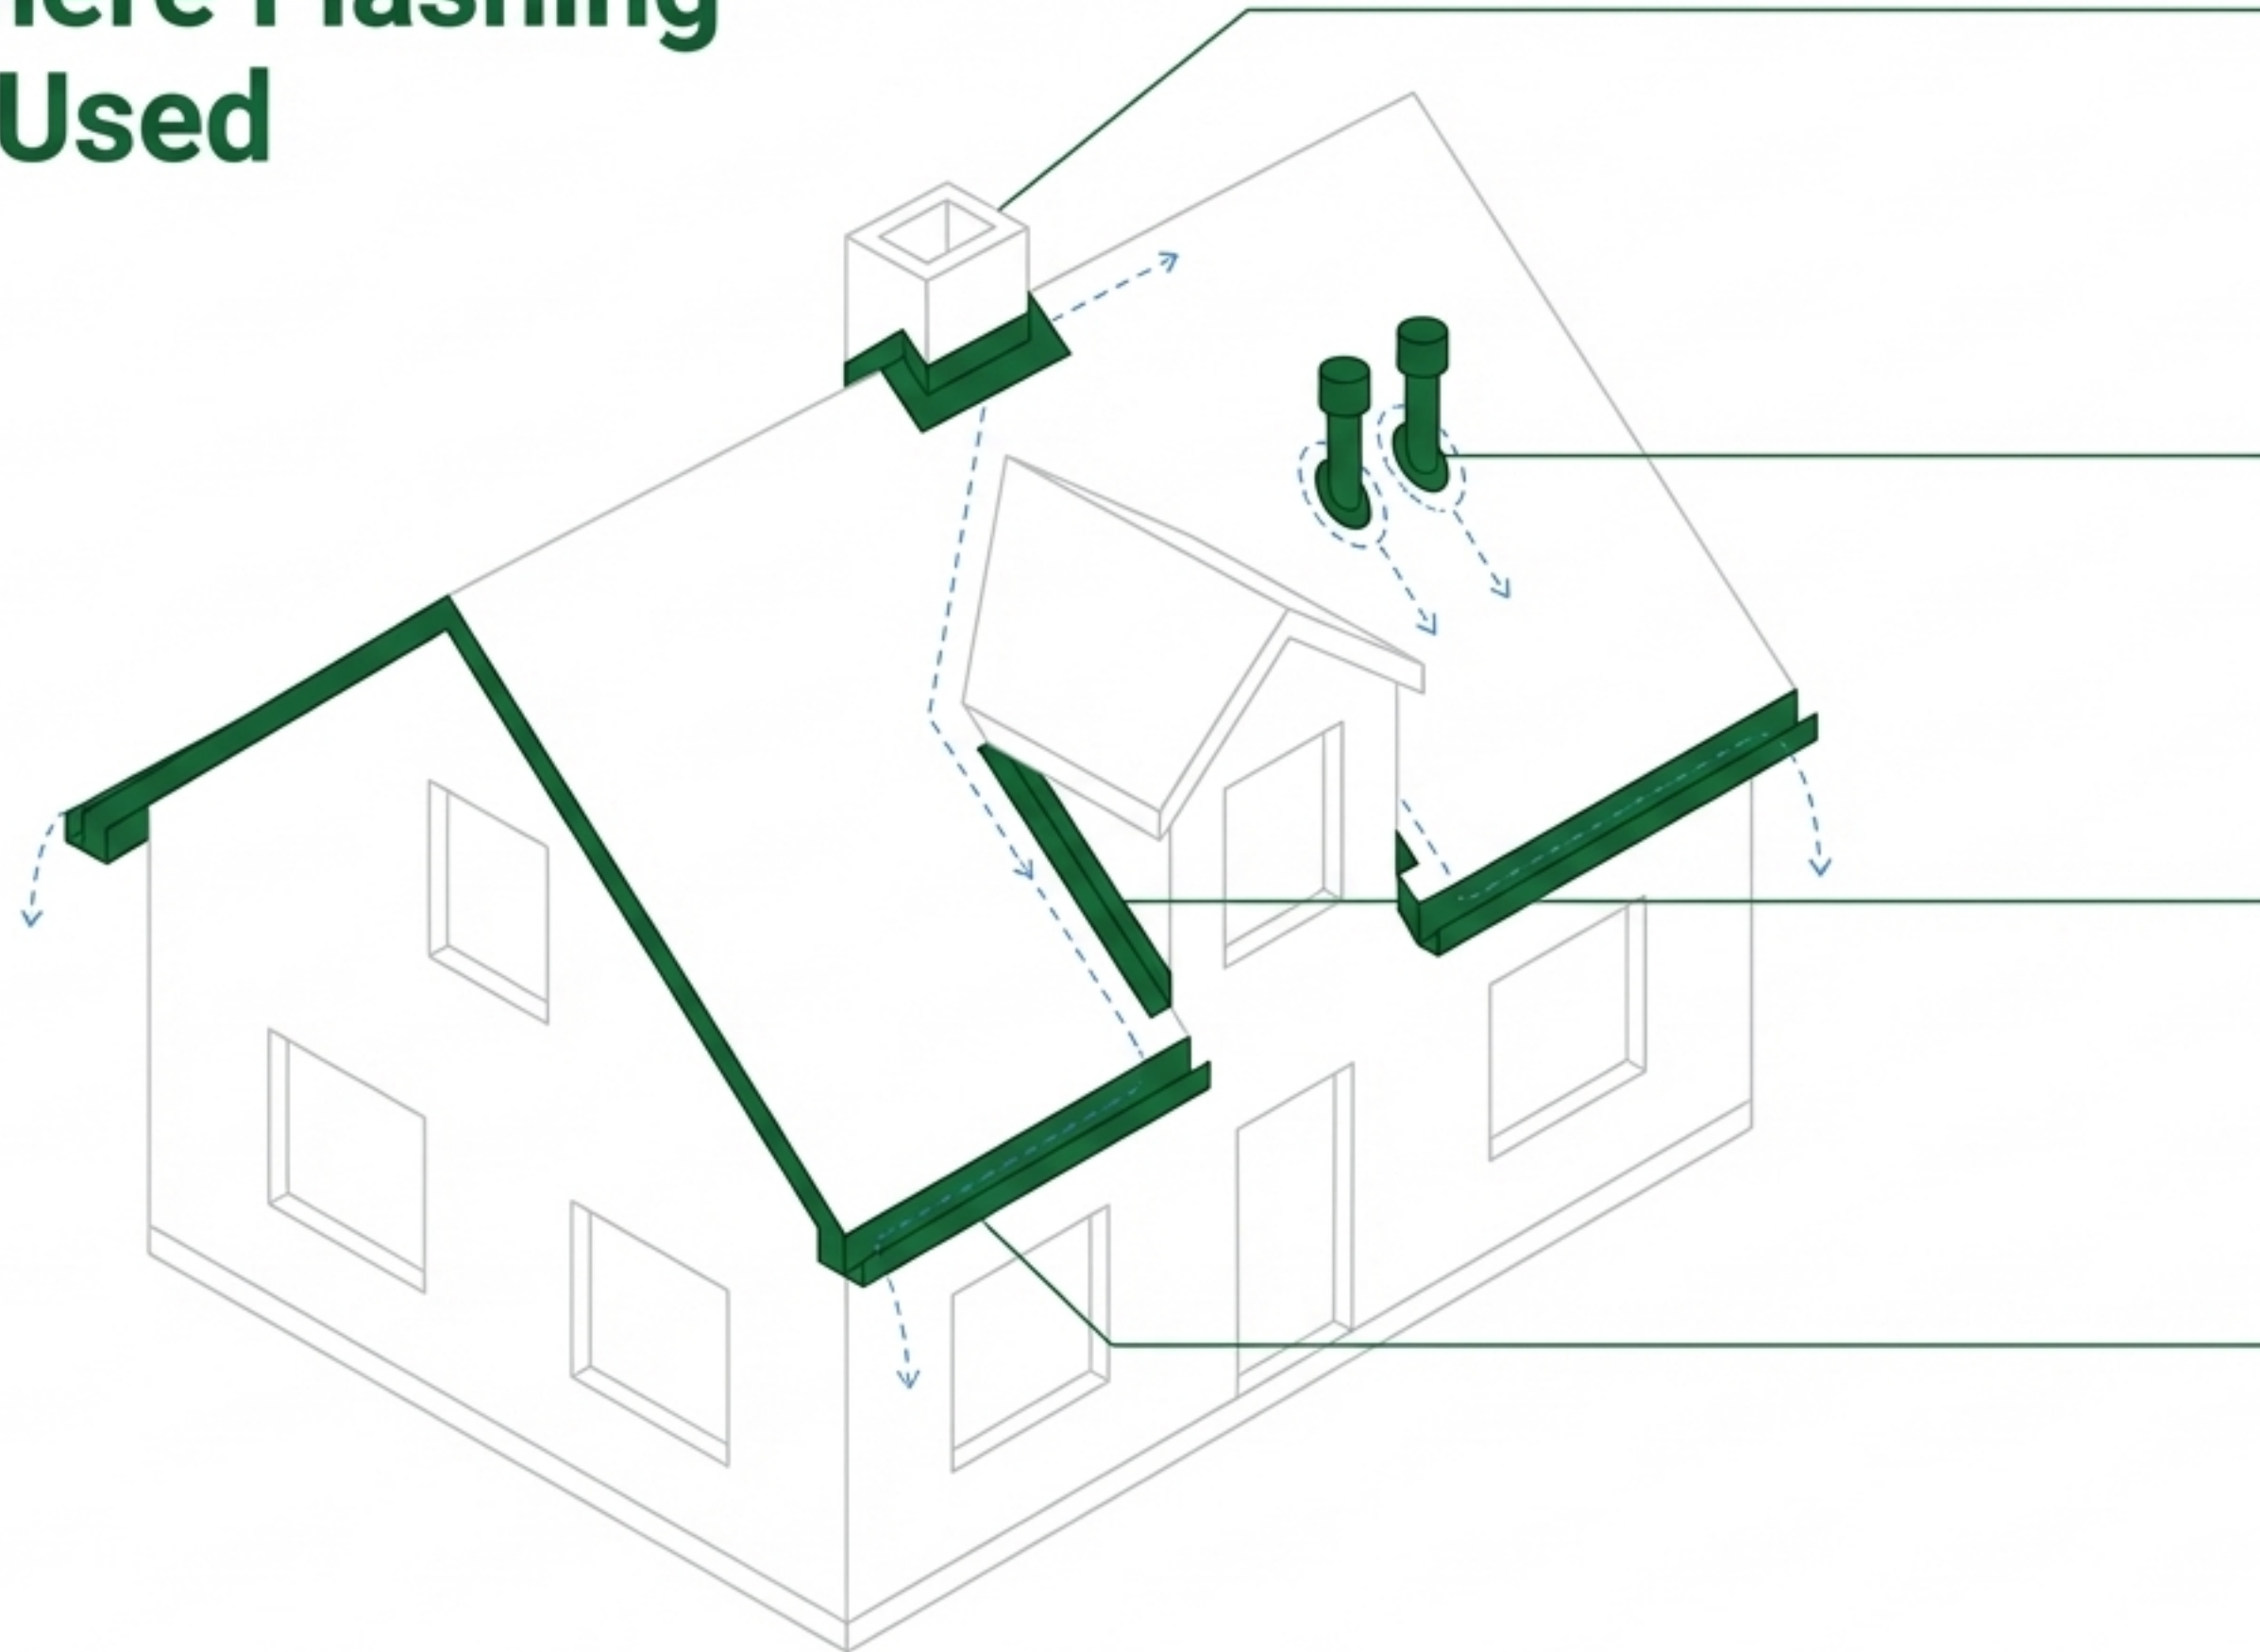
Chimneys

Complex, multi-layered assemblies (base, step, counter flashing, and saddles).

Vents & Pipes

Rubber or neoprene boots sealing exhaust and plumbing penetrations.

Walls & Valleys

Step flashing at dormers and continuous metal lining where two slopes converge.

Roof Edges

Drip edges running along eaves and rakes to direct water into gutters.

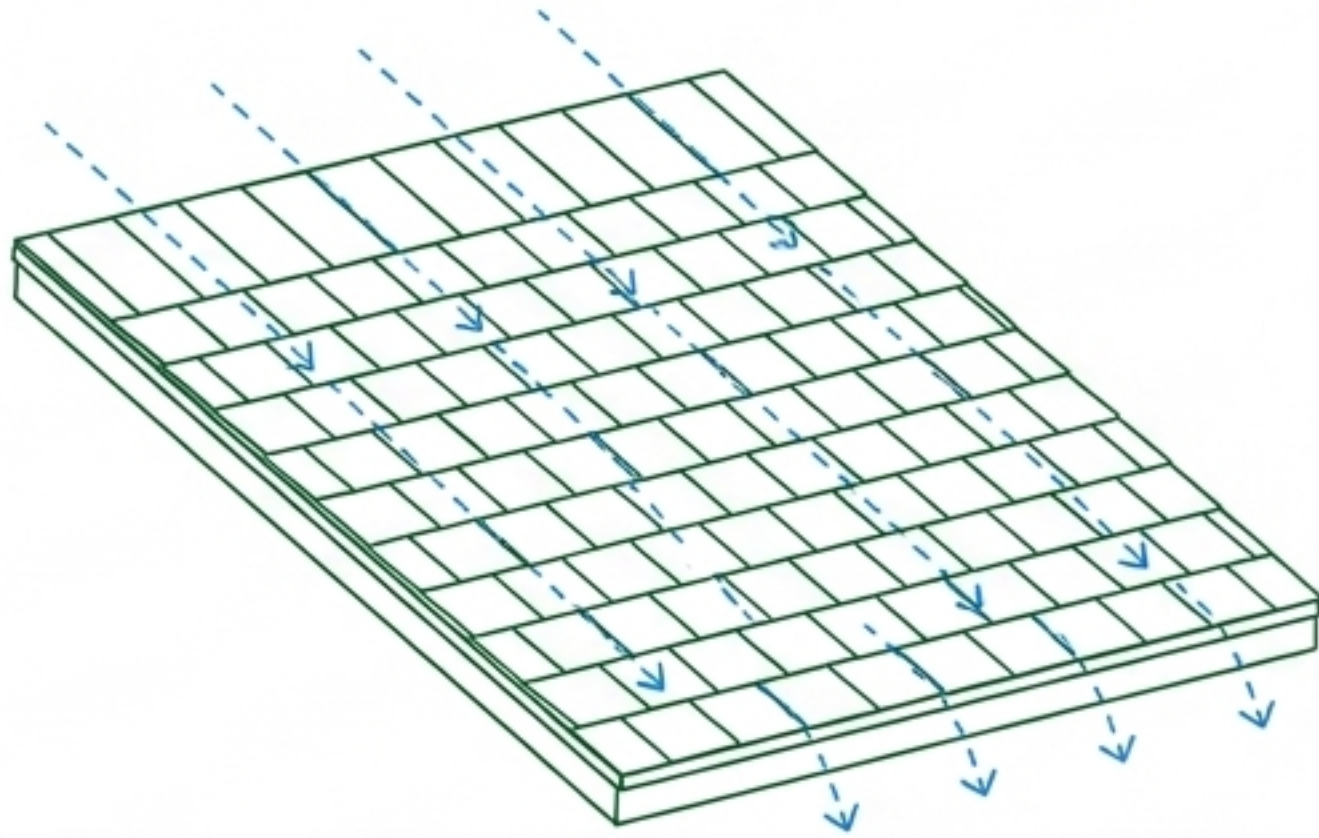
Continuous Surface

Shingles are engineered to shed water across continuous, uninterrupted surfaces.

Without structural obstacles, water naturally flows off the eave.

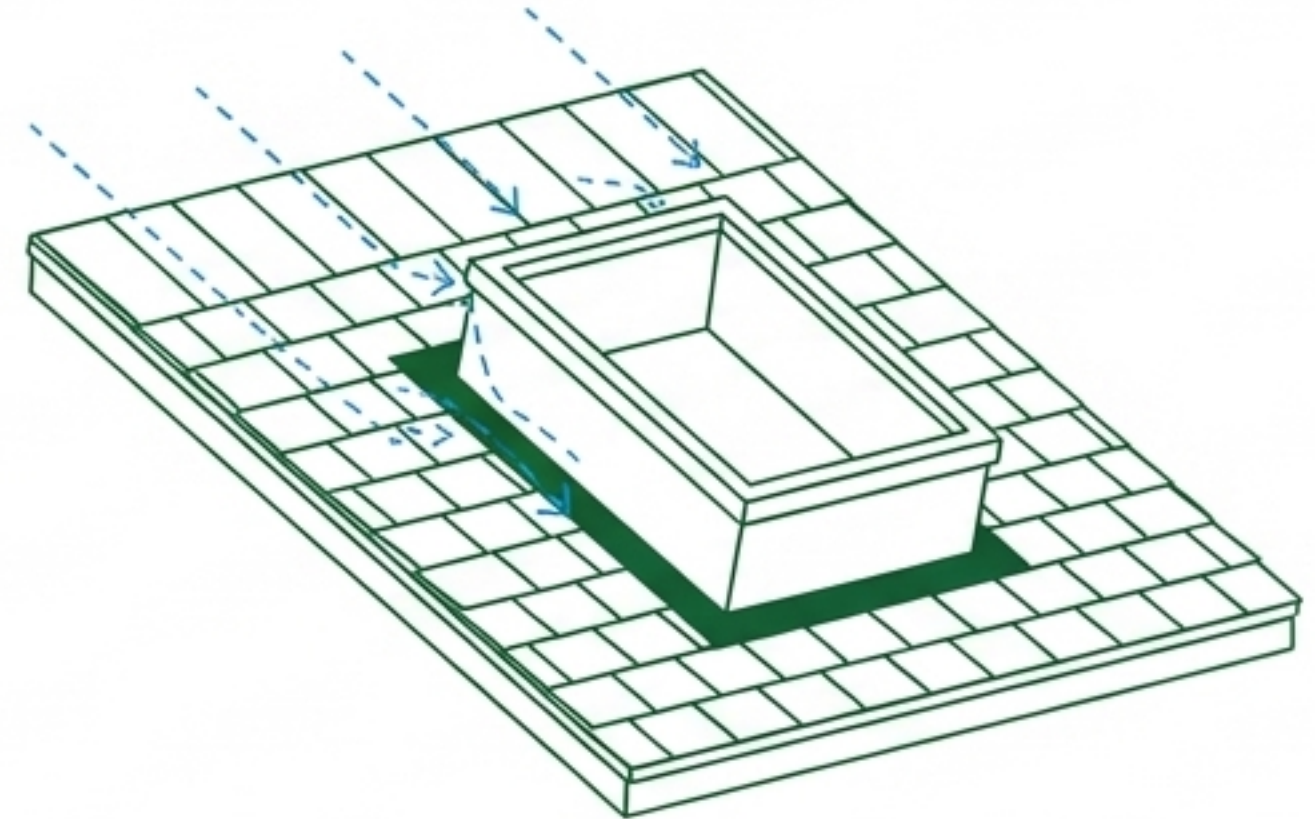
Interrupted Surface

Every architectural feature—chimneys, dormers, and skylights—creates a vulnerable structural joint.

Flashing serves as the required engineered barrier at these critical junctures where water pools.

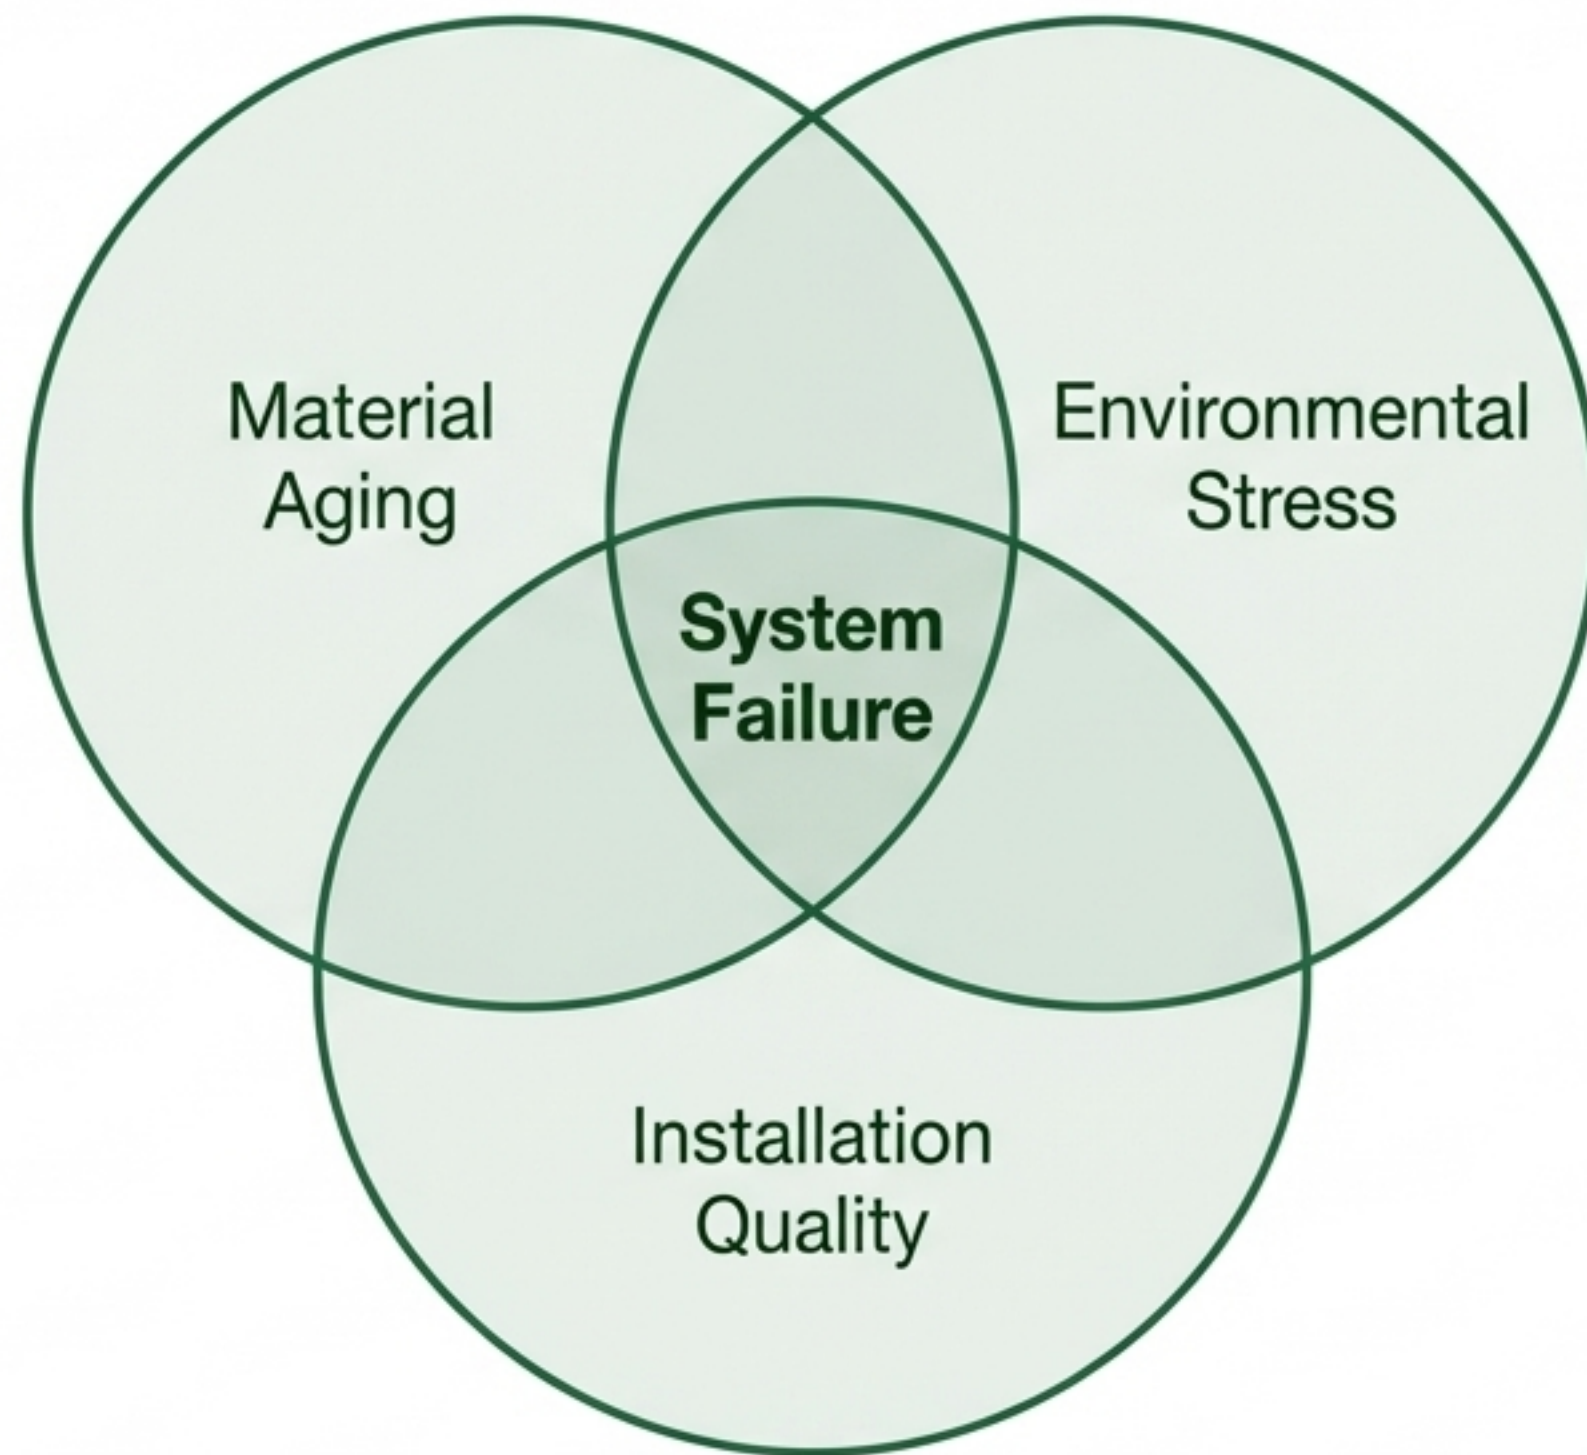
Deterioration occurs through multiple, compounding mechanisms over time.

Flashing reliably fails years before the surrounding shingle field shows significant wear.

Most residential roof leaks originate at these transition points, not the primary roof surface.

Latent issues—like insufficient metal overlap—often take years of cumulative exposure to manifest as leaks.

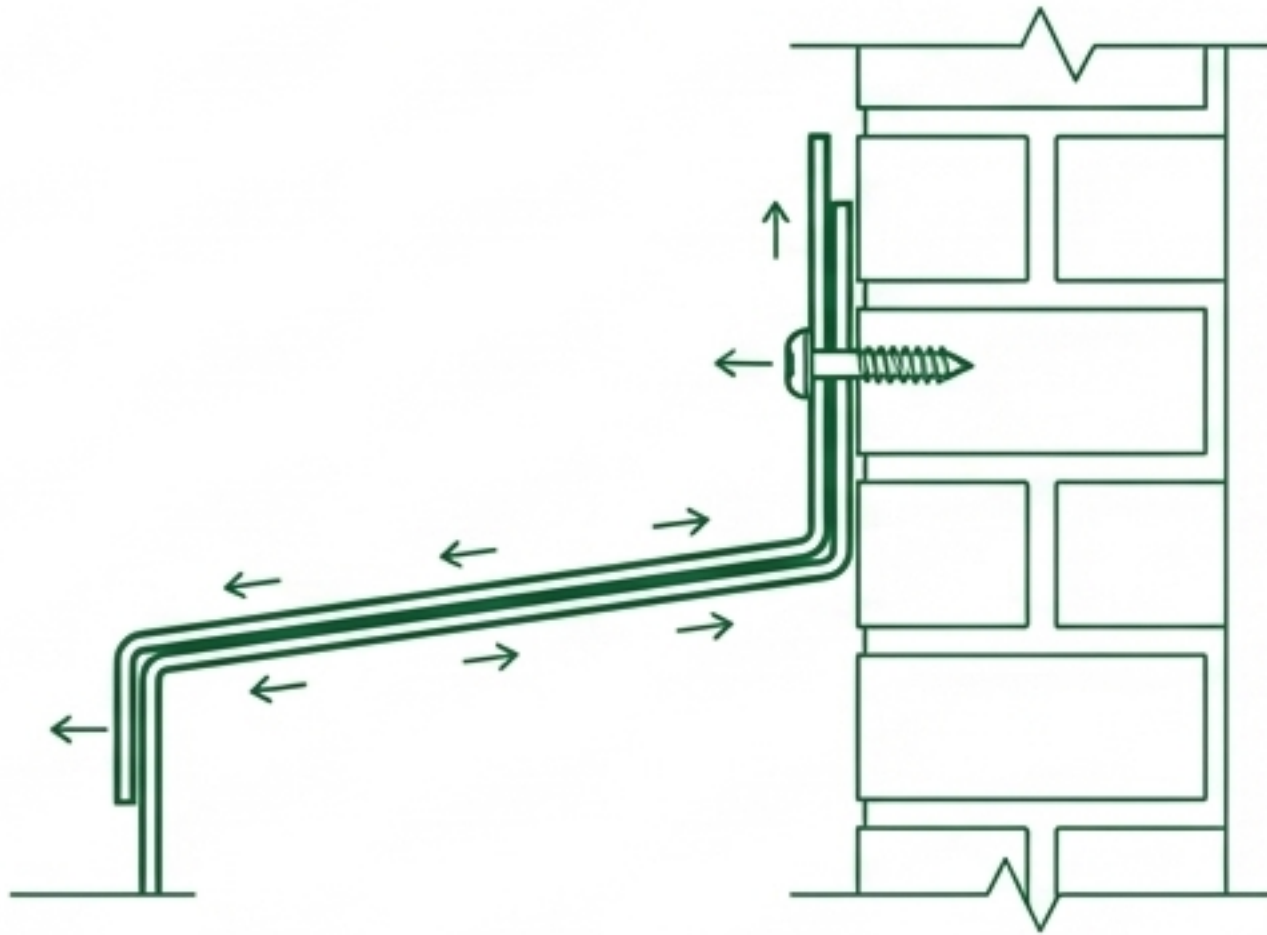
State A: Heat Expansion

- Roof temperatures fluctuate by 100+ degrees from a winter night to a summer afternoon.
- Metal components constantly expand and contract during daily thermal cycling.

- Dissimilar materials (metal flashing vs. masonry or wood) expand at fundamentally different rates.
- Over decades, this continuous movement slowly loosens fasteners and shifts lapped joints.

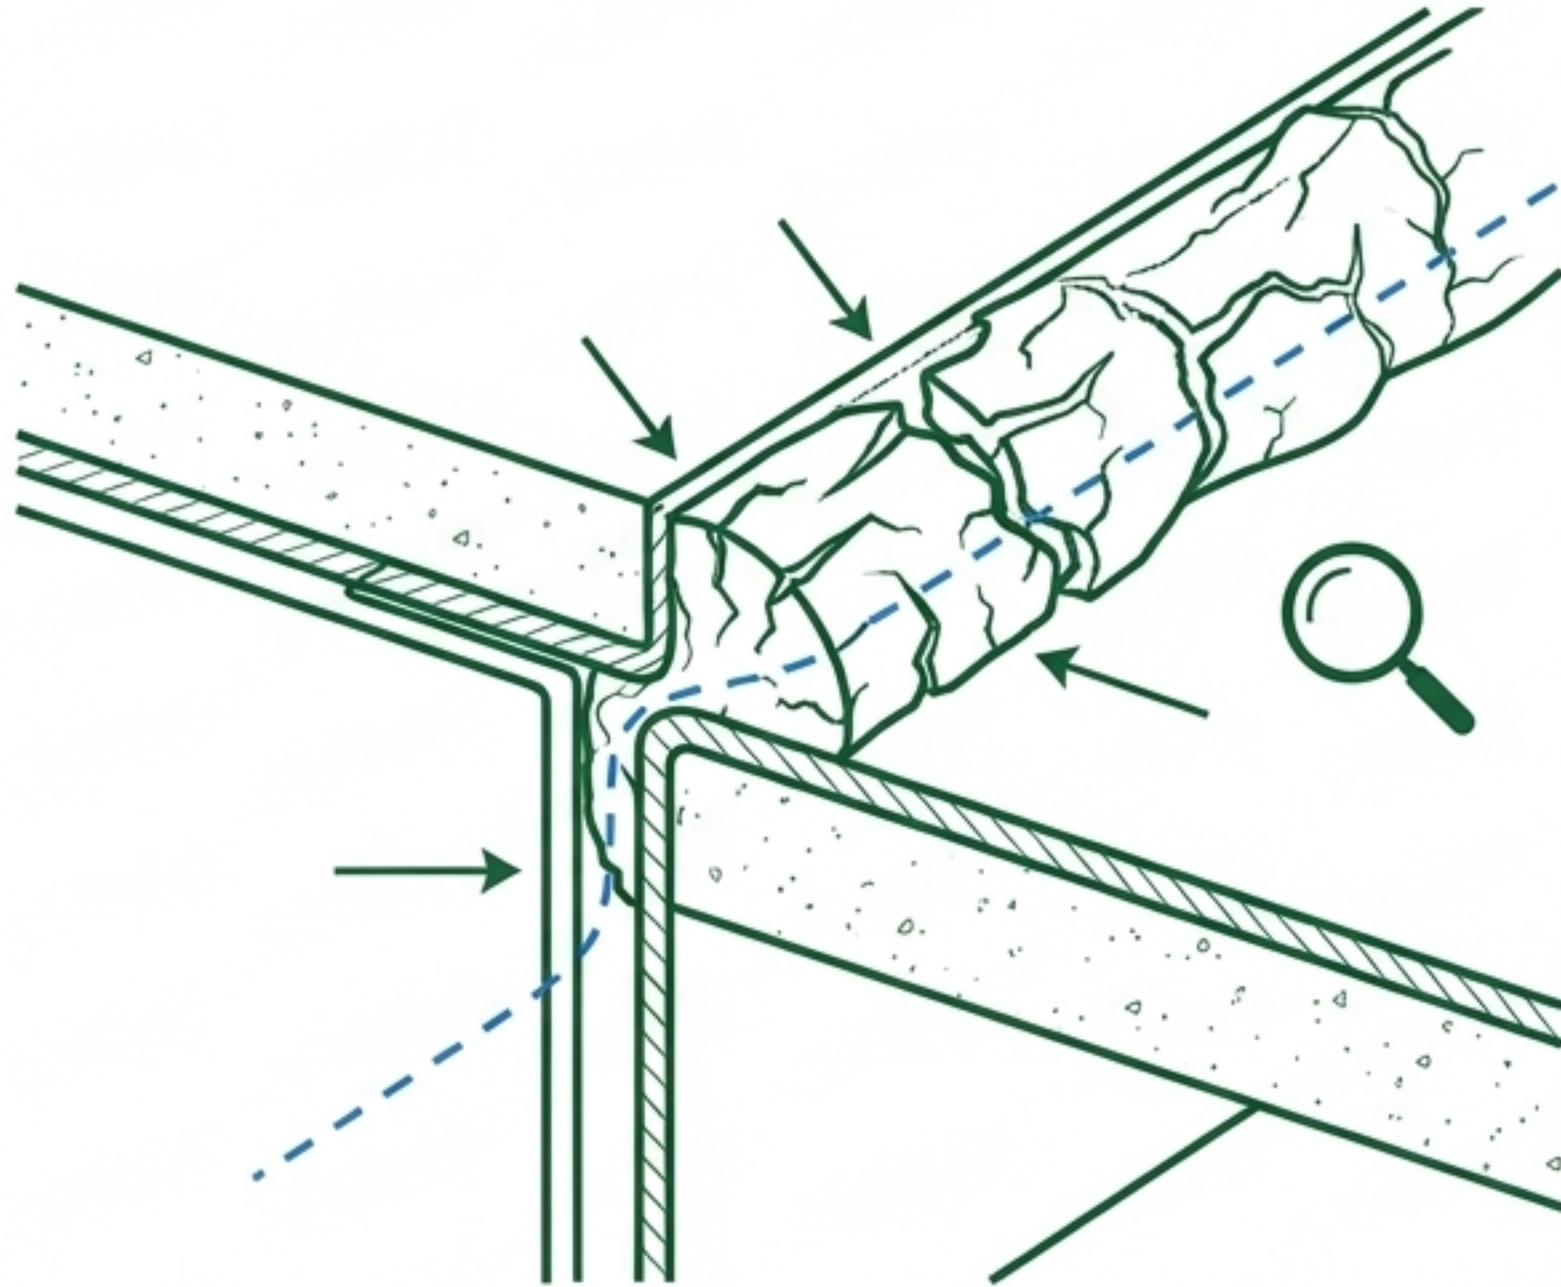
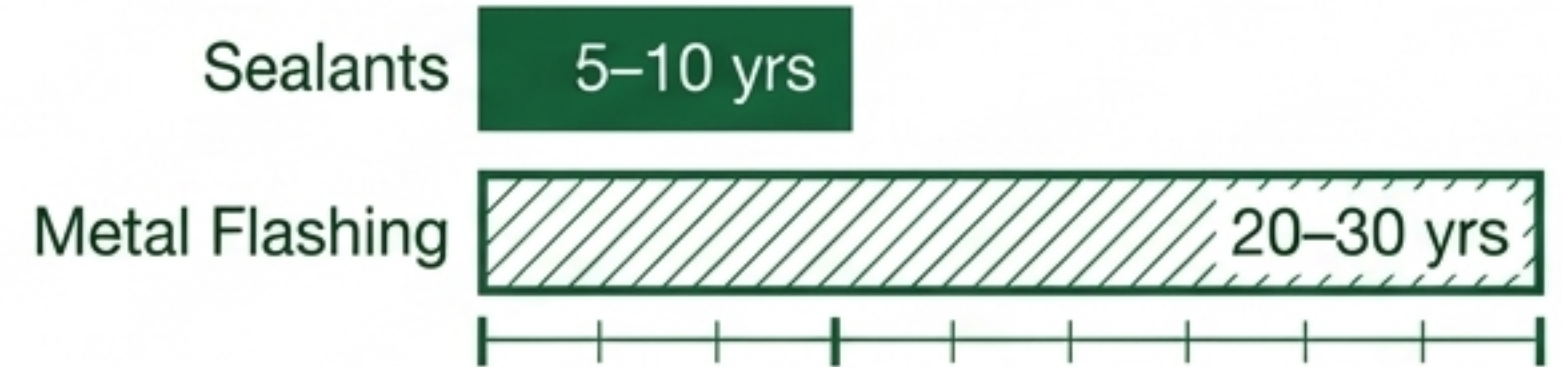
- Systems rely on sealants (caulk, butyl tape) to bridge minor gaps and secure termination points.
- Sealants degrade, shrink, and crack at a vastly accelerated rate compared to metal components.
- Typical sealants dry out within 5 to 10 years of harsh climate exposure.
- Once a sealant fractures, the underlying joint loses its primary defense against water entry.

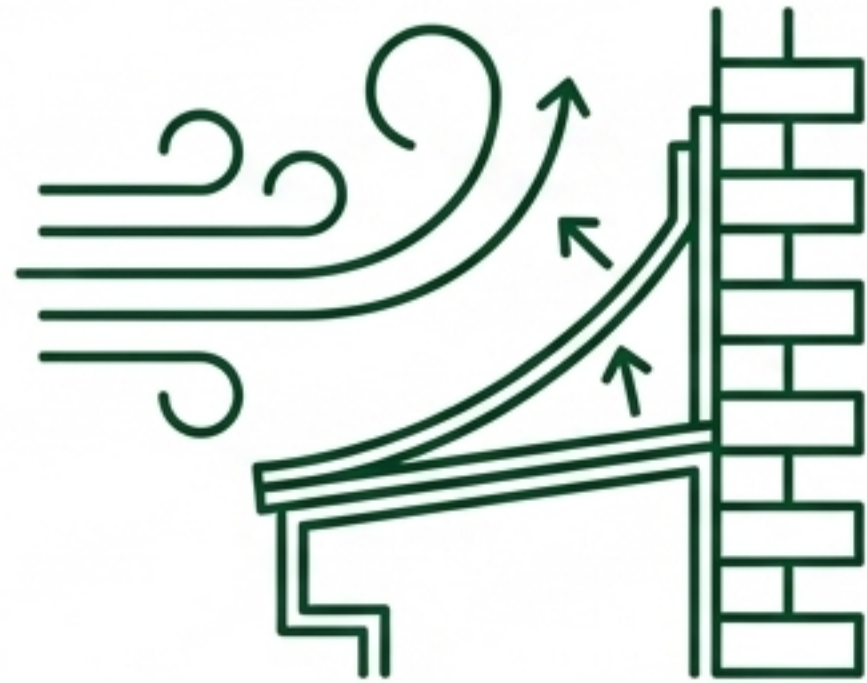
High Winds

Lift counter flashing and physically shift layered pieces out of their sequential structural order.

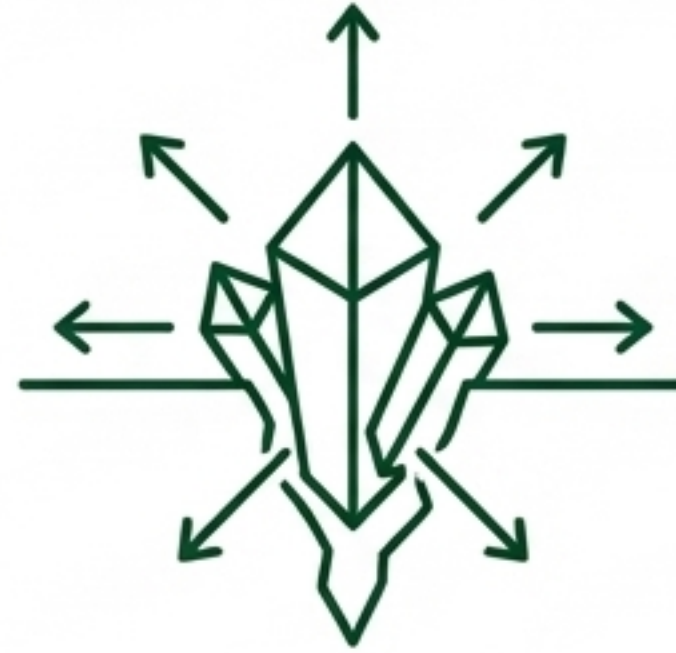
Freeze-Thaw Cycles

Trapped moisture freezes, expands, and forcibly widens existing micro-gaps overnight.

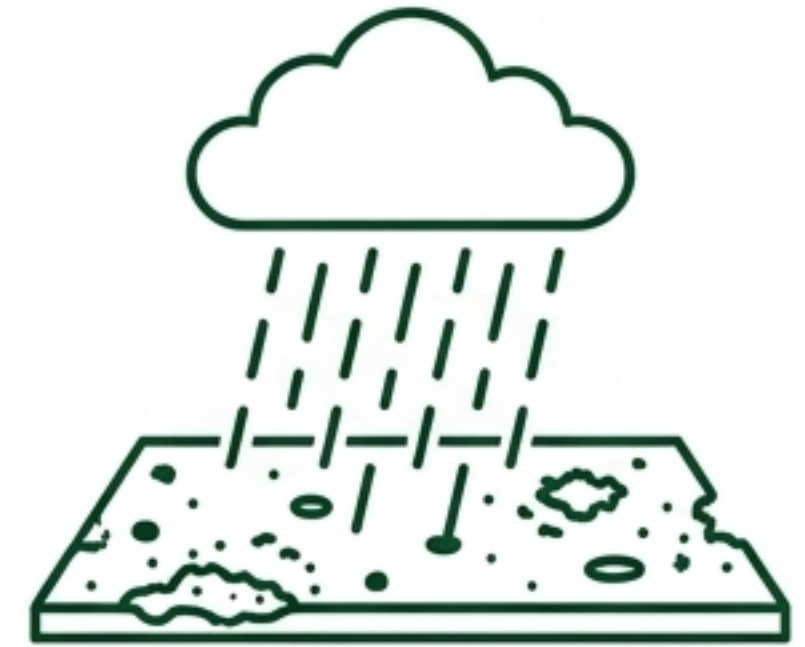
Corrosion

Sustained moisture depletes galvanized zinc coatings over 20–30 years, resulting in rust and pinhole perforations.

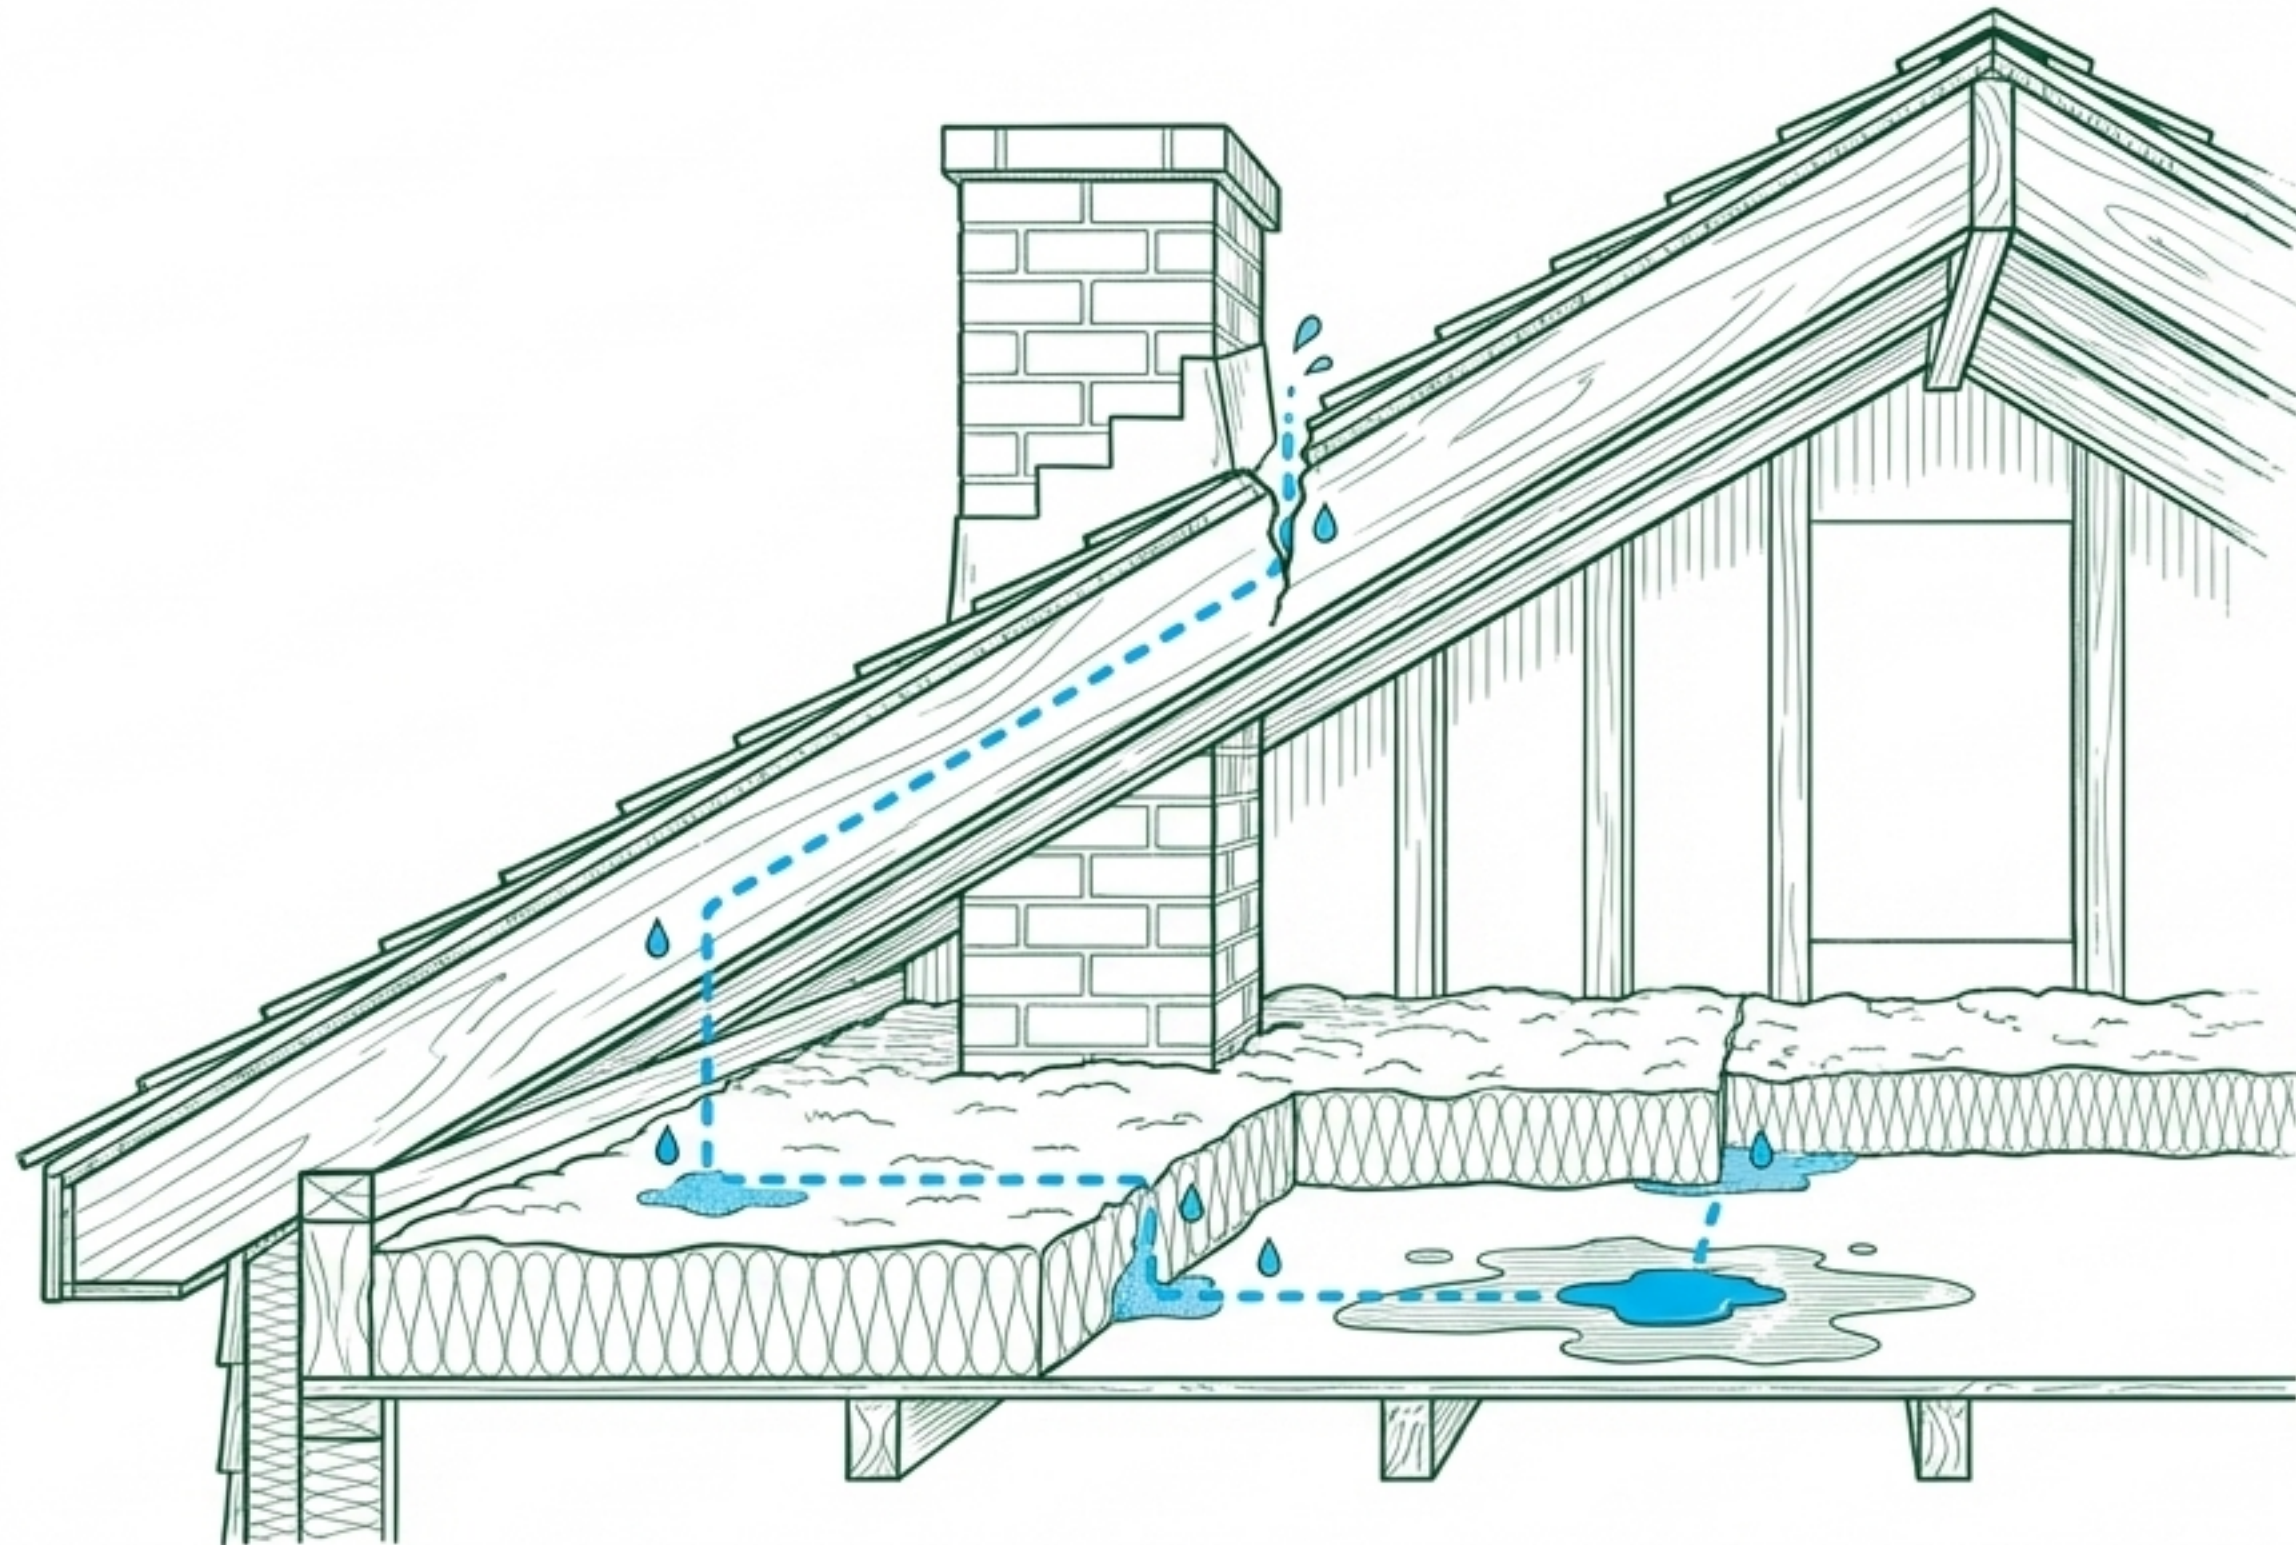
Interior ceiling stains frequently appear far from the actual exterior point of failure.

Water follows the path of least resistance, traveling horizontally along rafters and sheathing.

Visible exterior signs—like surface rust or missing caulk—are often the only early indicators.

Comprehensive failures remain entirely hidden from the ground until secondary interior damage occurs.

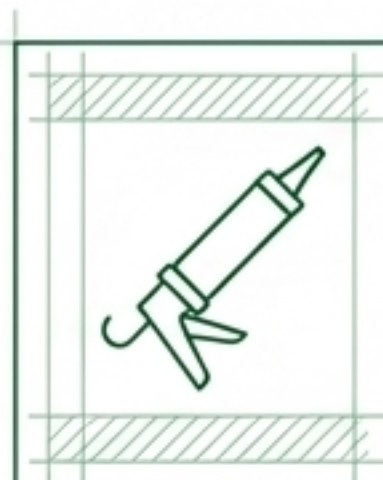
The Sealant Fallacy

Applying a bead of caulk over a structural gap is a temporary patch, not a repair.

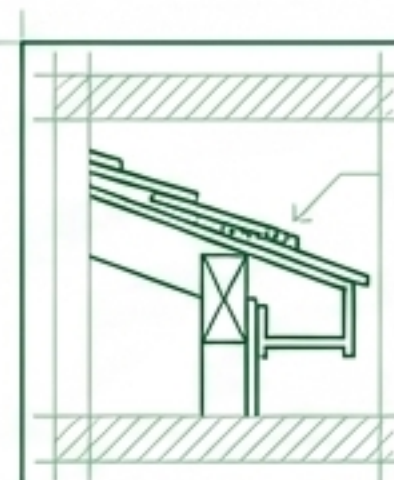
Proper Protocol

True repair requires removing adjacent shingles, replacing the metal, and correctly sequencing the overlapping layers.

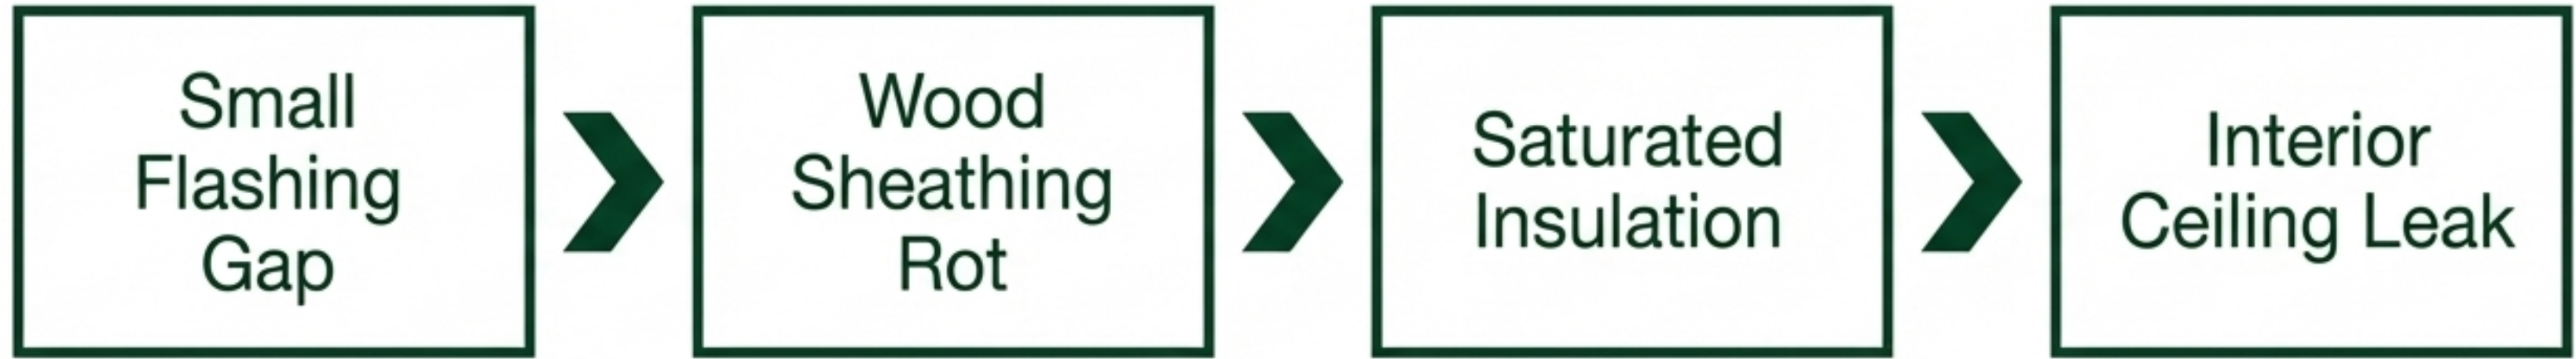
Water intrusion begins slowly, routinely bypassing the living space entirely during early stages.

Trapped moisture silently deteriorates wood decking, decking, rafters, and structural supports in the attic cavity.

Proactive physical inspections identify dried sealants and micro-gaps before metal structural failure failure occurs.

Early, targeted maintenance effectively prevents expensive, large-scale system rot.
