What Happens During a Roof Inspection in New Jersey

A Step-by-Step Homeowner's Guide

Presented by: T.A. Hughes III Roofing, Siding & Windows

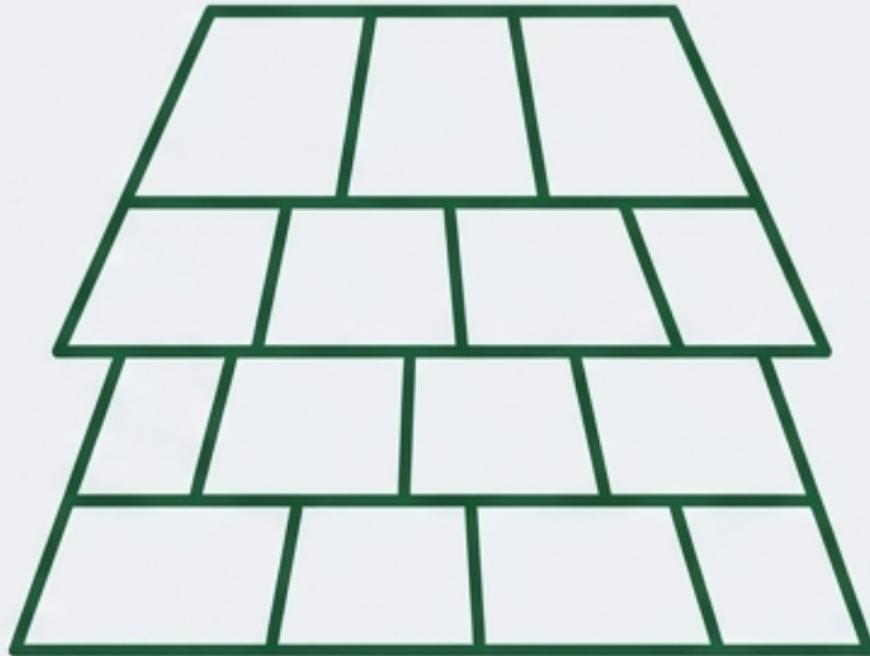
Step 1: Exterior Shingles

Zone 1: The Target

Overall exterior condition, material age, and UV-protective coating.

Zone 2: The Threat

Wind displacement, weather damage, and natural material degradation.

Zone 3: The Clues

- Missing, displaced, or curling edges.
- Granule loss (bald spots on shingles).
- Cracking, brittleness, or surface blistering.

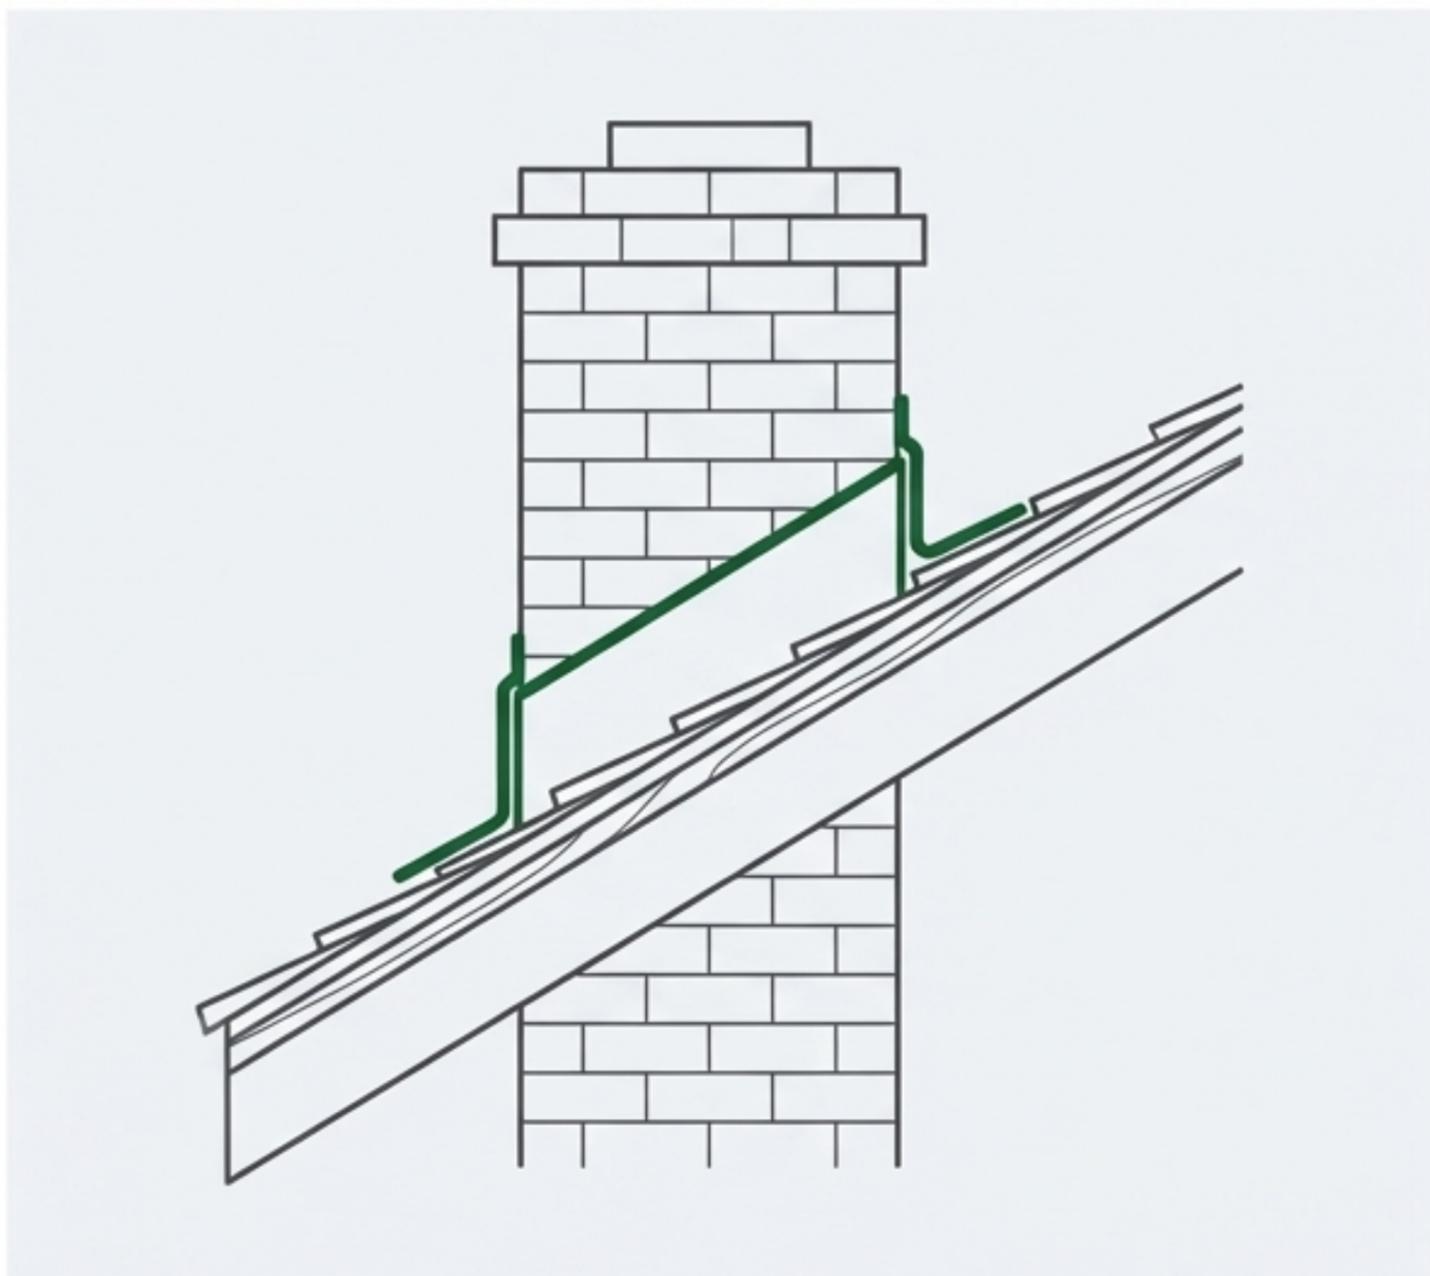
Step 2: Flashing Integrity

The Target

Metal seals at joints, chimneys, vents, skylights, and dormers.

The Threat

Flashing failures are the leading cause of roof leaks in South Jersey homes.

The Clues

- Dried, cracked, or deteriorated caulking.
- Metal lifting or separating from the surface.
- Rust, corrosion, or gaps caused by temperature shifts.

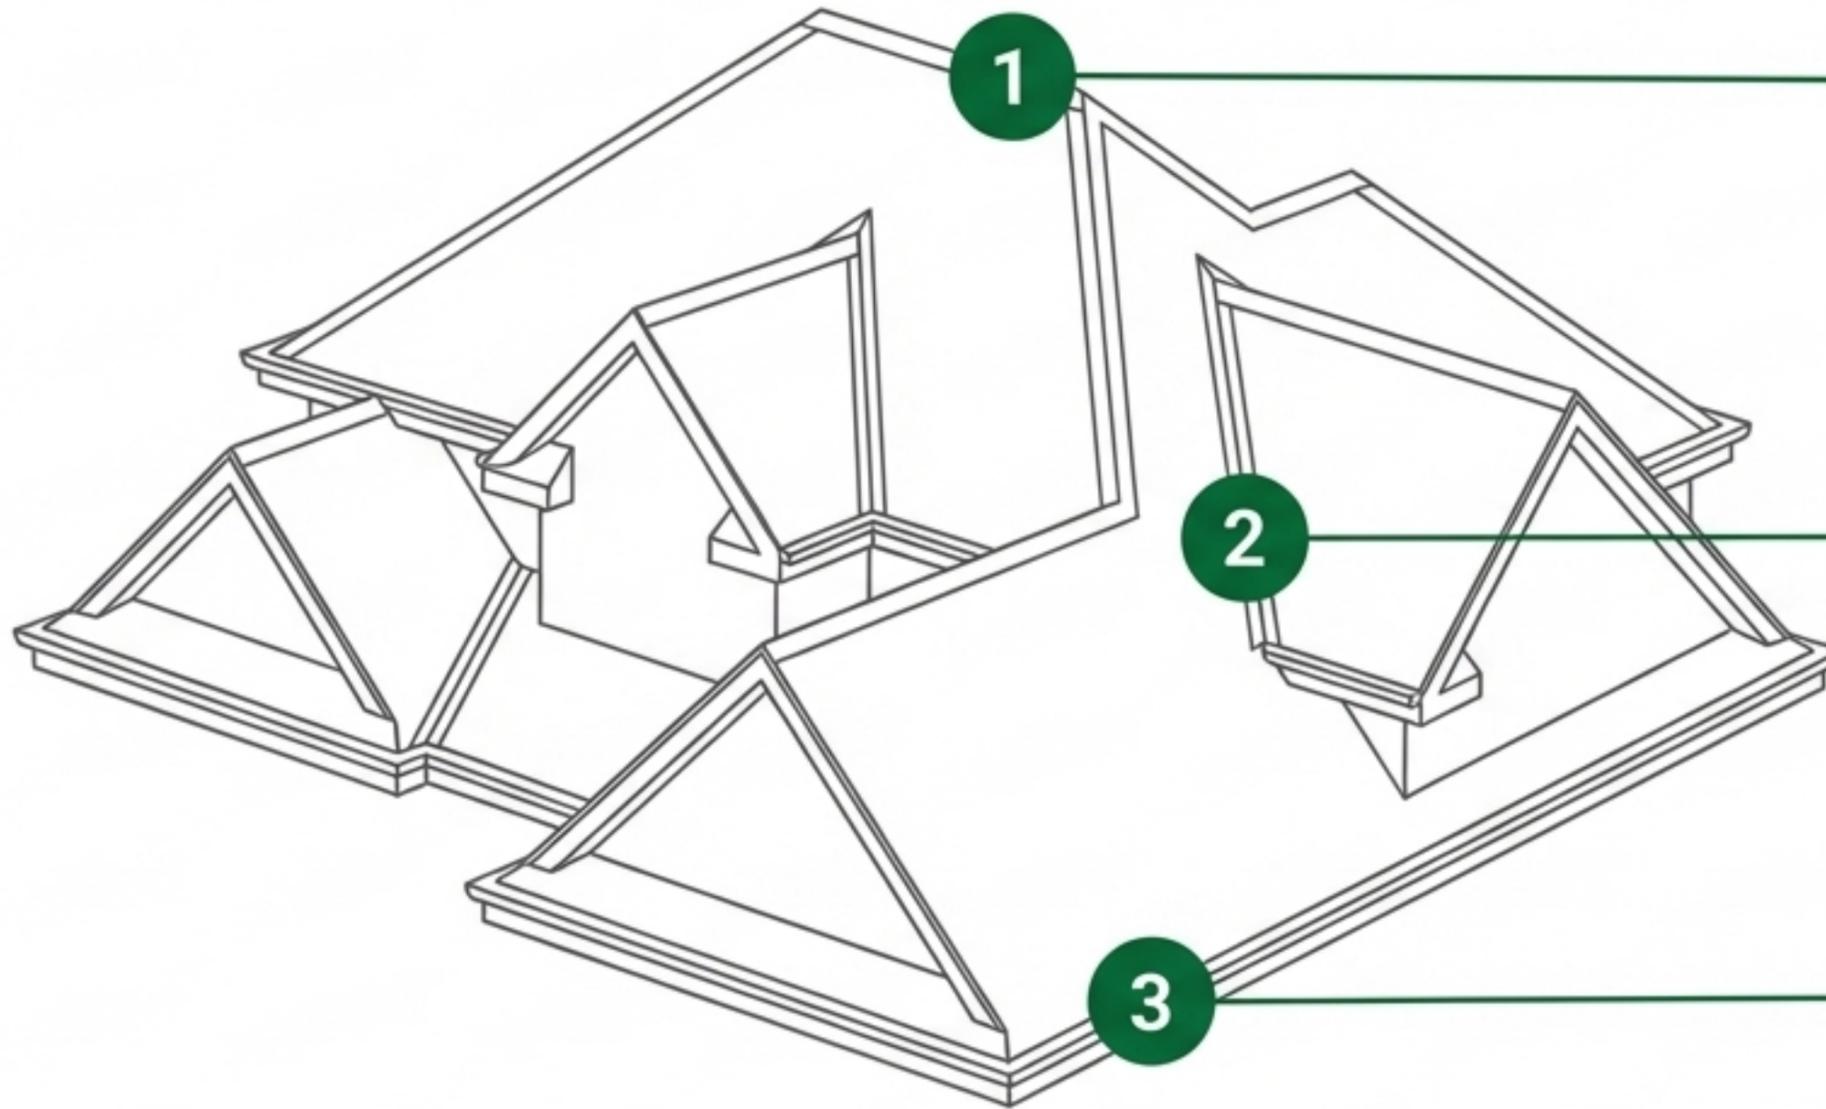
Step 3: Roof Structure

The Ridge (Peak)

Verifying proper alignment, coverage, and intact capping.

The Valleys

Inspecting these high-traffic water channels for intact flashing or properly woven shingles.

The Edges

Checking the condition of the drip edge along the eaves and rakes to ensure water sheds correctly into gutters.

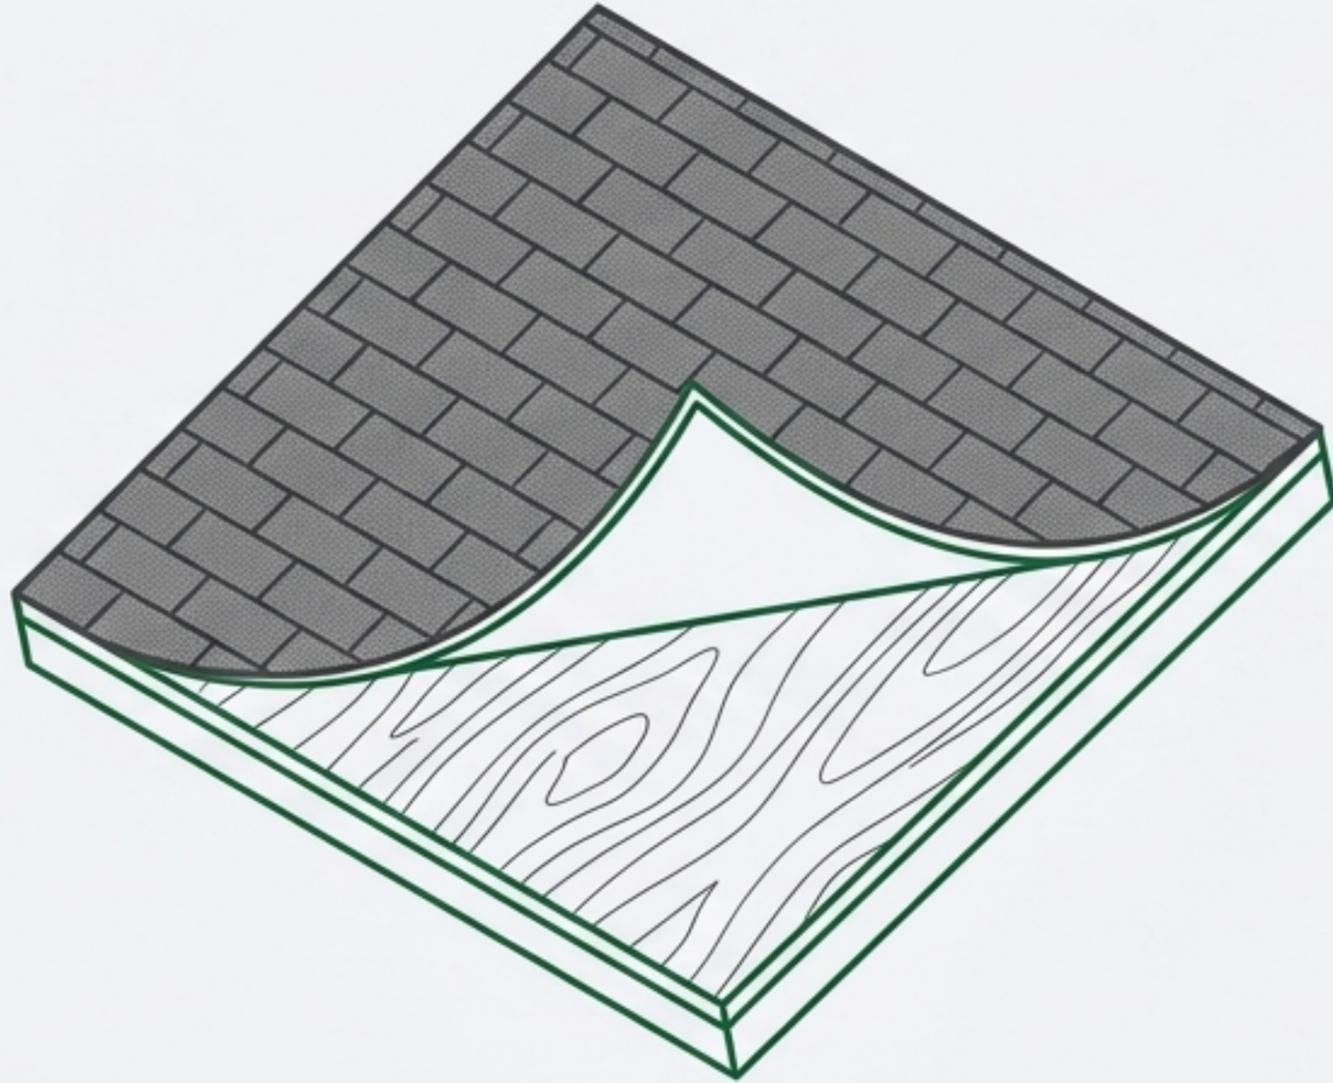
Step 4: Decking Assessment

The Foundation

Evaluating the plywood or OSB board directly beneath the shingle layer.

Structural Integrity

Checking the walking surface for soft spots, sagging areas, or warping.

Moisture Clues

Looking for tell-tale water staining visible at the outer edges or previous leak activity.

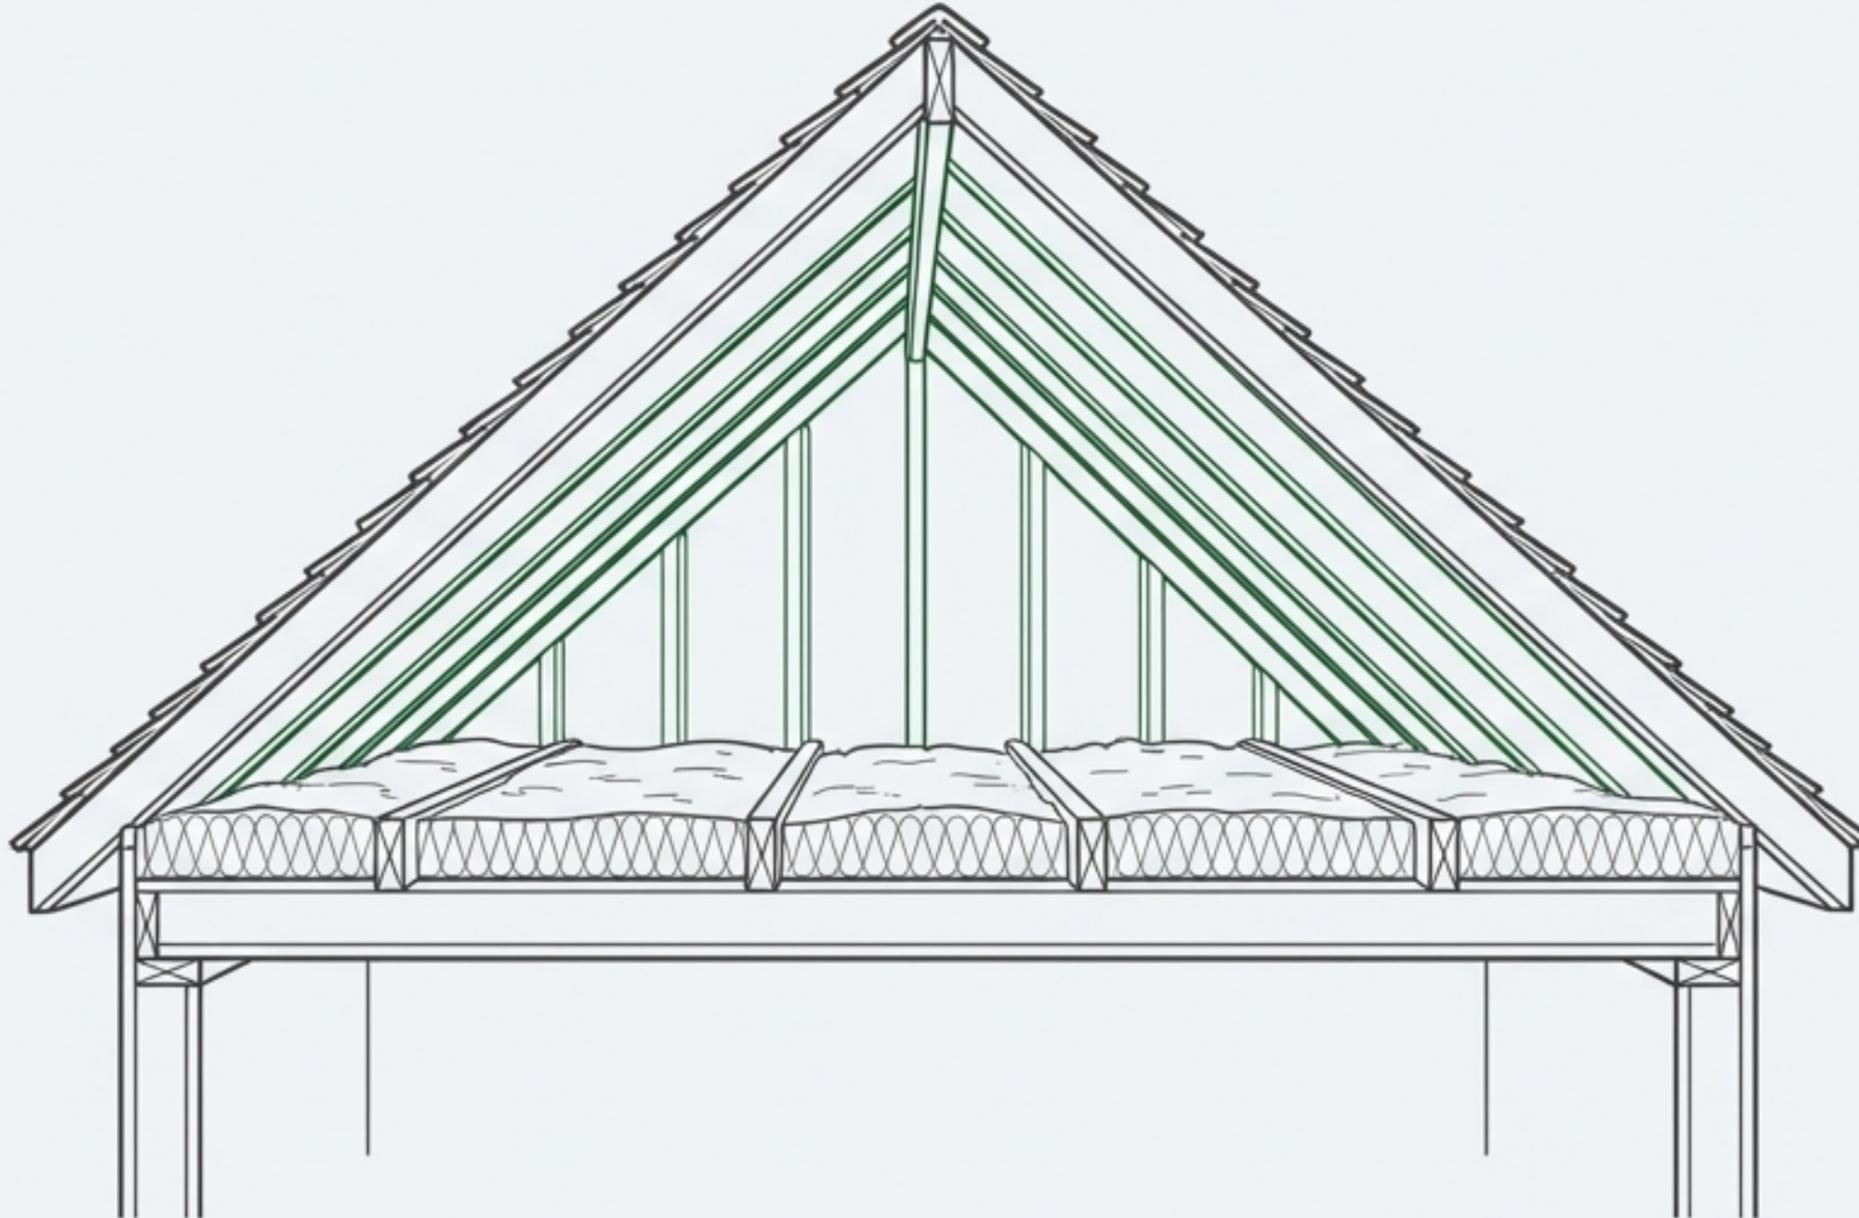
Step 5: Attic Inspection

The Inside Story

Assessing the roof's health from the interior reveals what the exterior hides.

Moisture Intrusion

Checking rafters and sheathing for active water staining or daylight showing through gaps.

Hidden Threats

Identifying signs of mold, mildew, or inadequate insulation coverage linked to moisture.

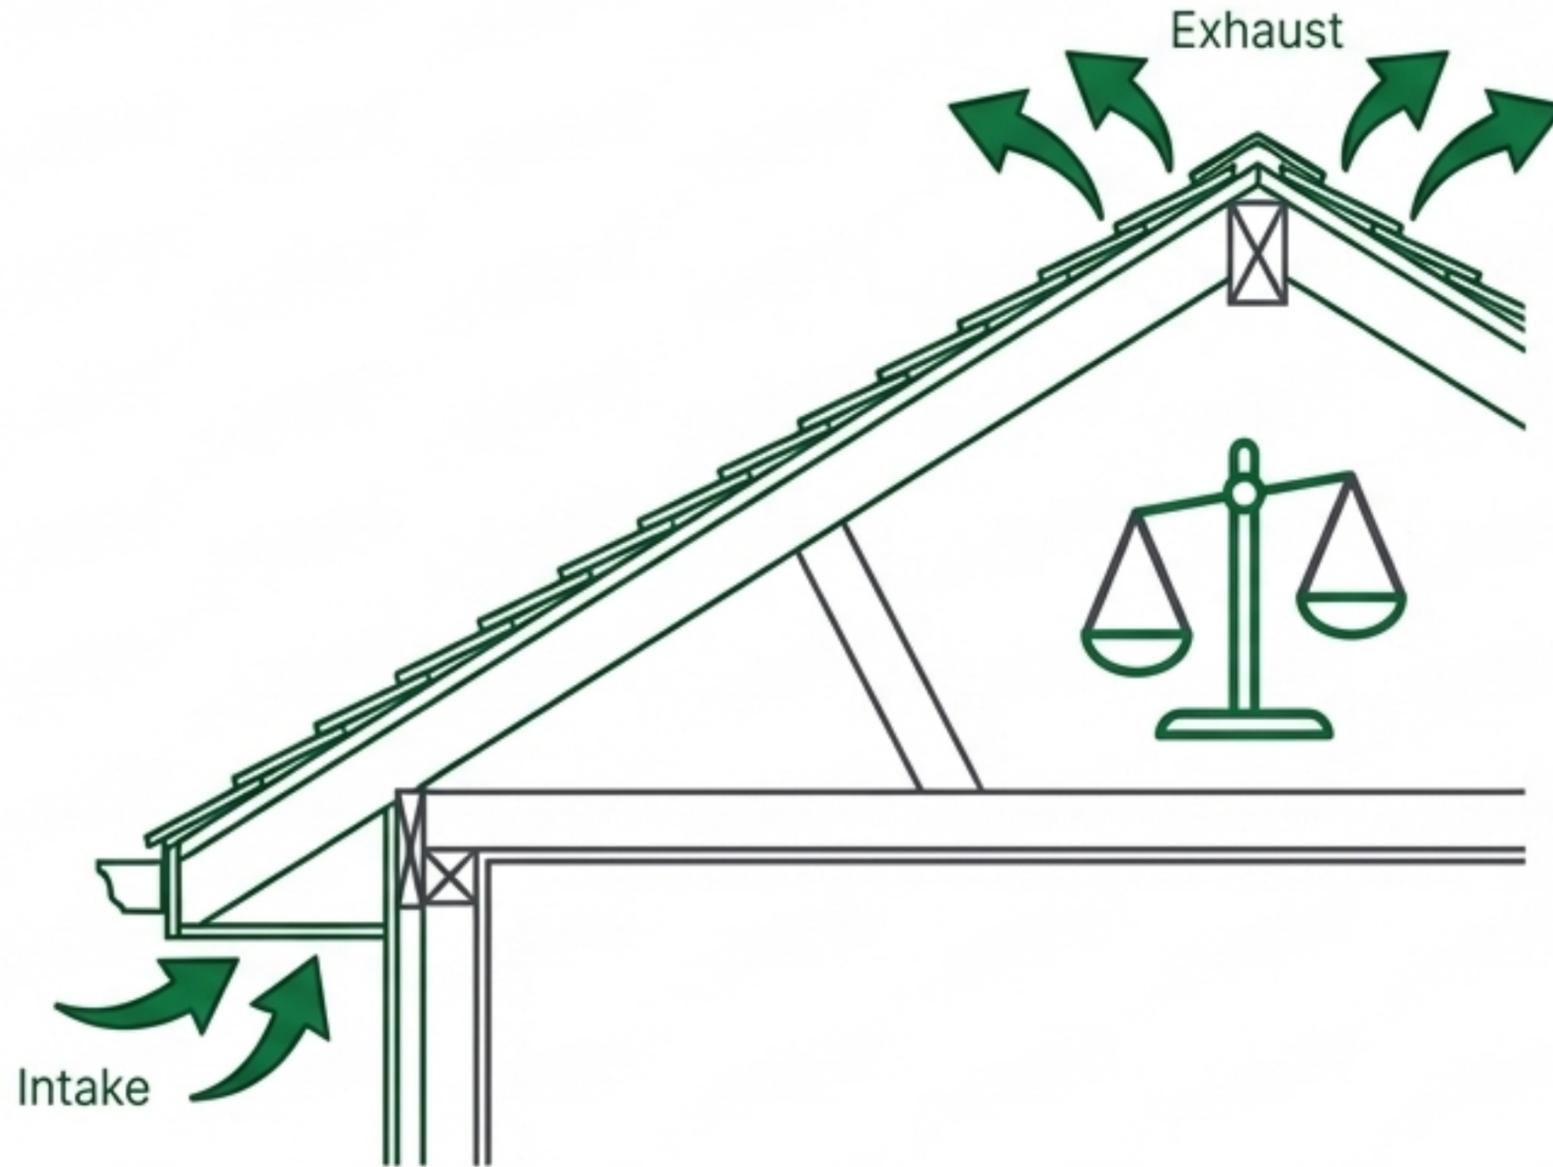
Step 6: Ventilation Balance

System Balance

Evaluating the crucial ratio of soffit intake vents to ridge exhaust vents.

Temperature Control

Poor ventilation traps heat, dramatically shortening shingle lifespan and raising summer cooling costs.

Moisture Management

Proper airflow is required to prevent winter ice dams and stop attic mold growth.
