Why Do Roof Shingles Lose Granules Over Time?

An educational guide to understanding roof aging, weather impact, and what to look for.

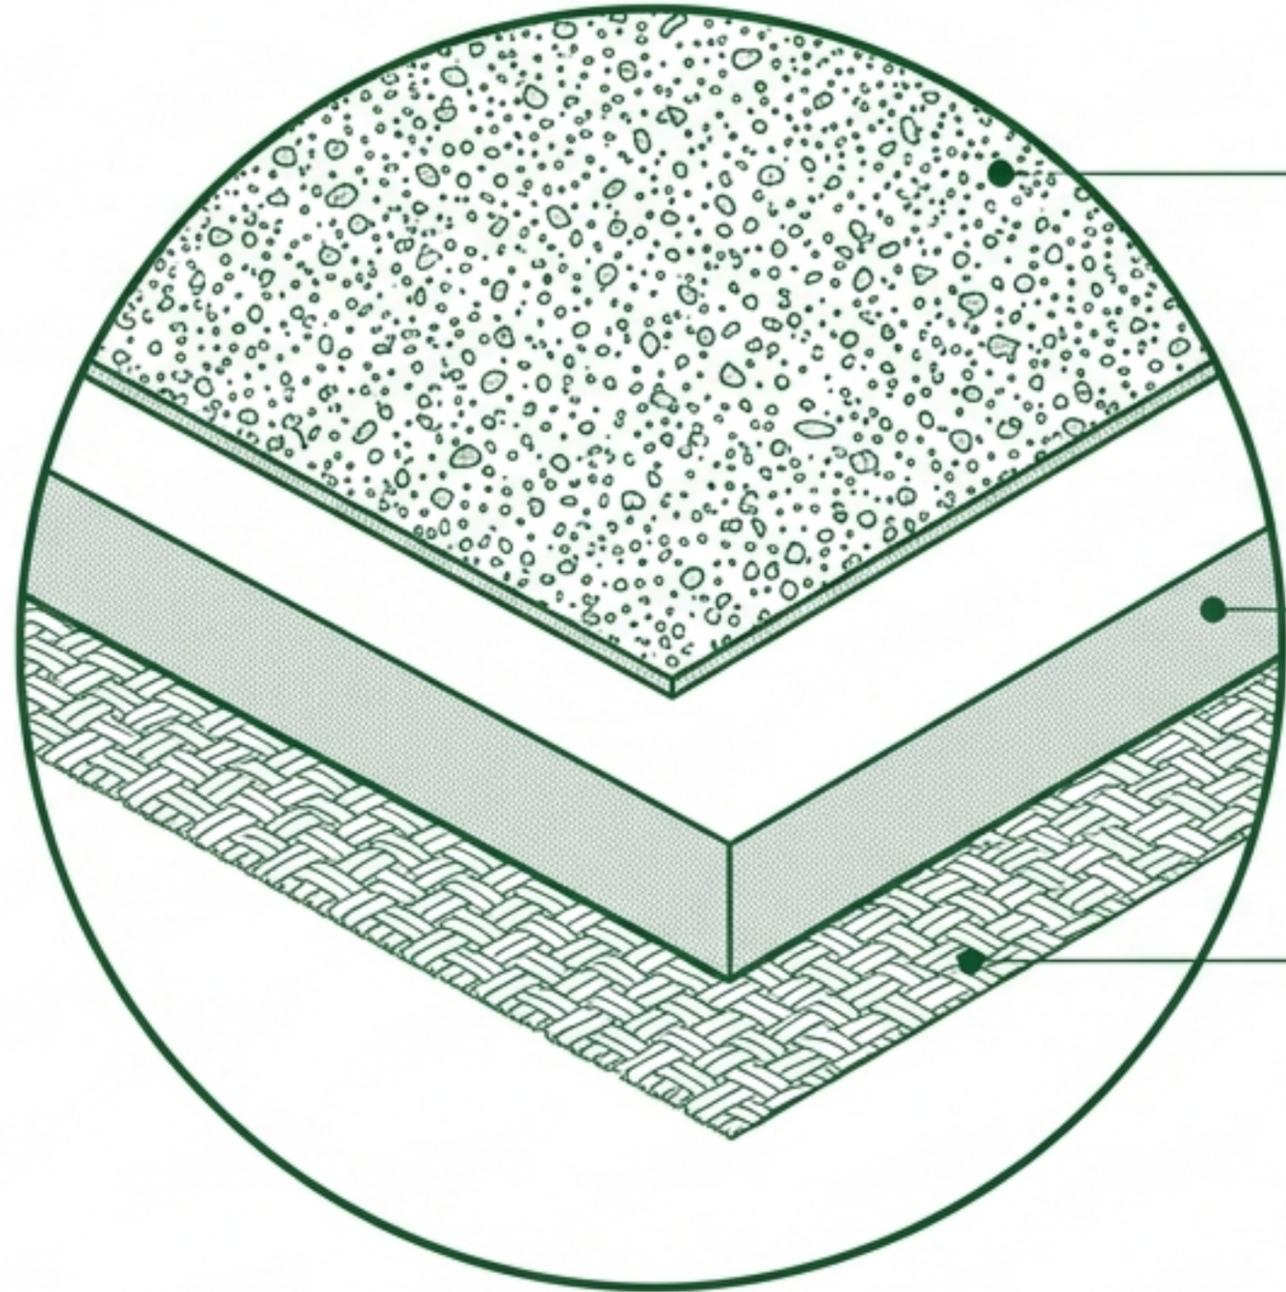
The Anatomy of an Asphalt Shingle

Ceramic-Coated Granules

Rough, sand-like minerals pressed into the surface. Highly engineered for long-term environmental durability.

Waterproofing Asphalt

The thick core layer that provides actual water resistance and flexibility.

Fiberglass Mat

The foundational structure that gives the shingle its tear strength and shape.

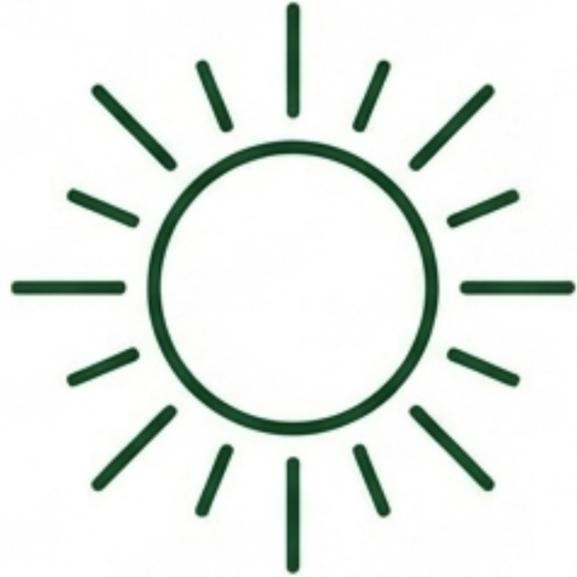
UV Protection

Granules absorb and deflect sunlight, preventing the underlying asphalt from drying out, becoming brittle, and cracking.

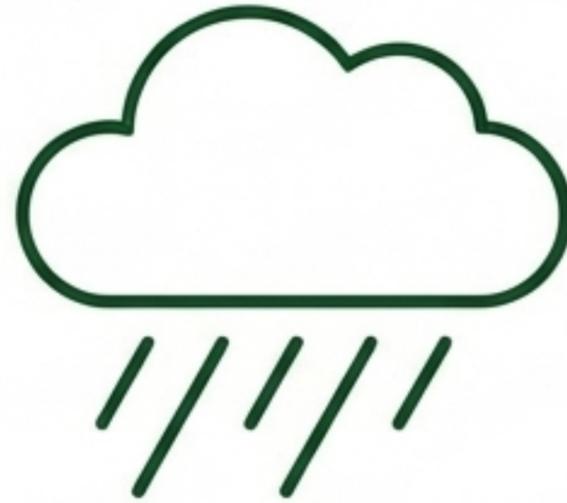
Weather Resistance

The rough mineral surface provides a durable physical shield against rain impact, wind-driven debris, and hail.

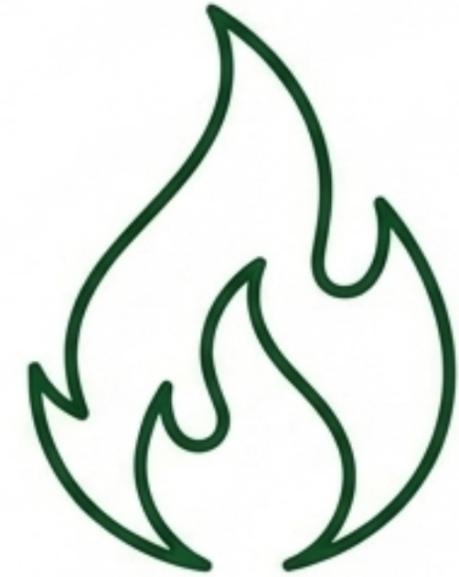
Fire Resistance

The mineral composition adds a crucial layer of non-combustible protection to the overall roofing system.

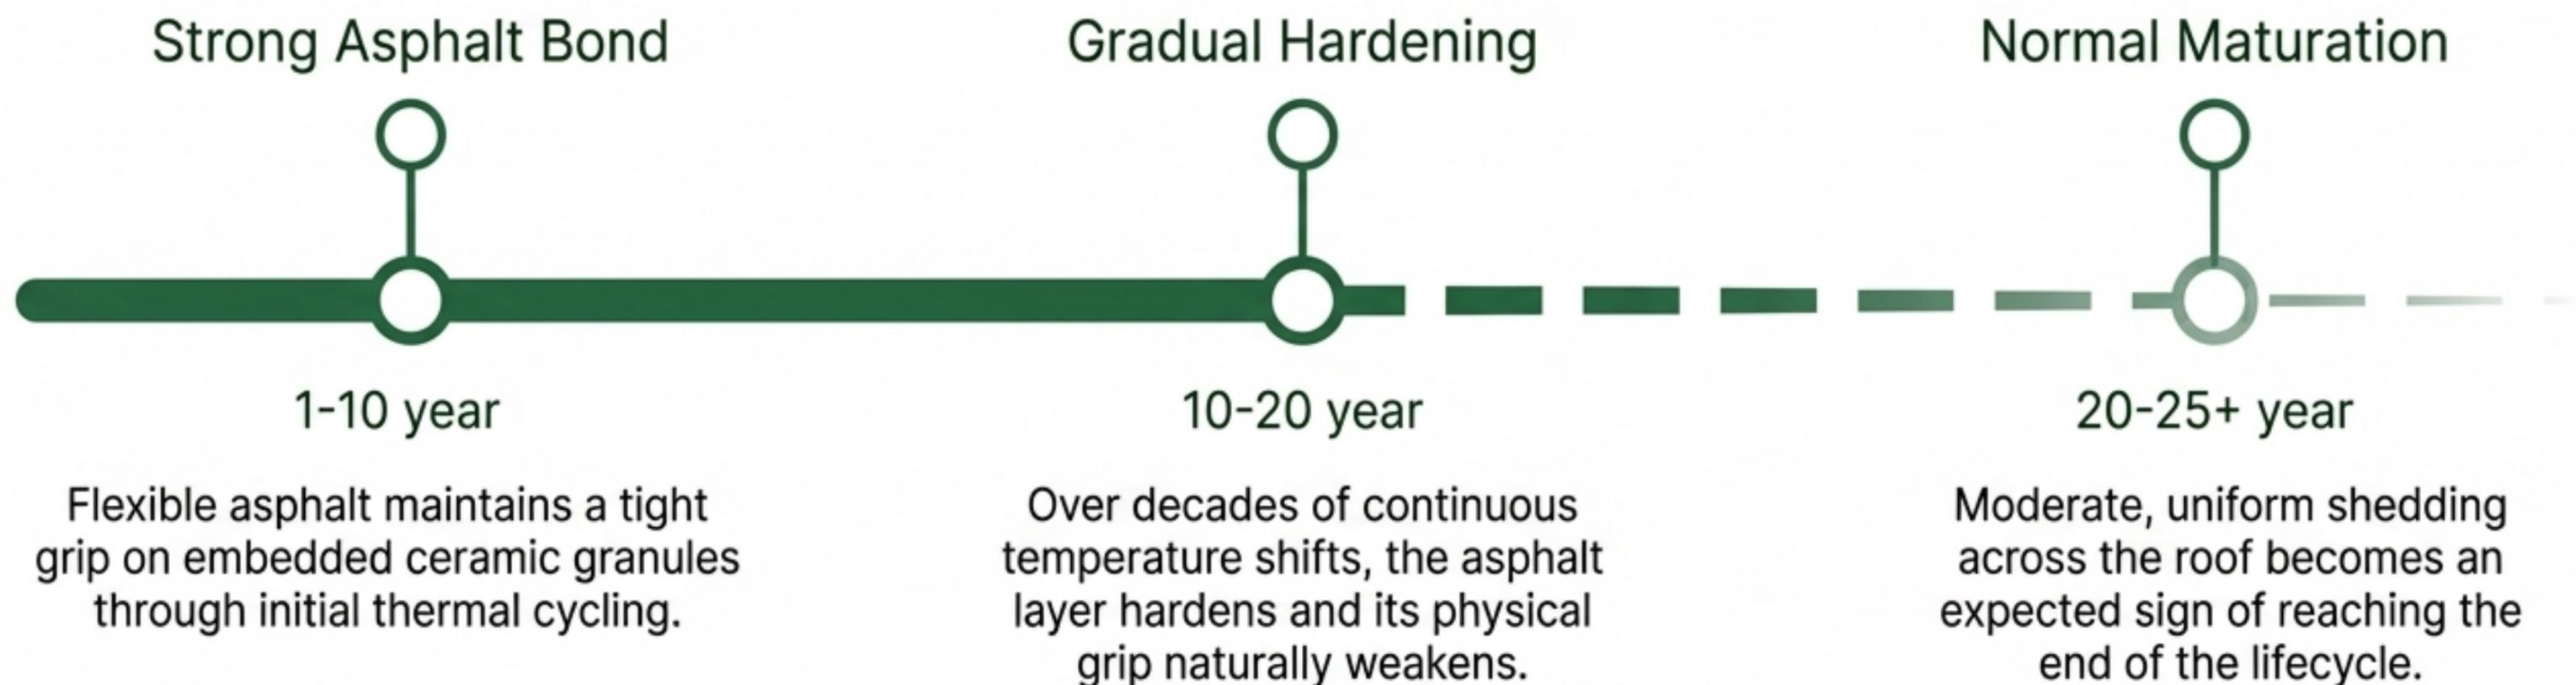
Intrinsic Factors: The Timeline of Normal Aging

Note for South Jersey: Roofs on homes built in the 1980s and 1990s are currently in the prime window for this natural, age-related shedding.

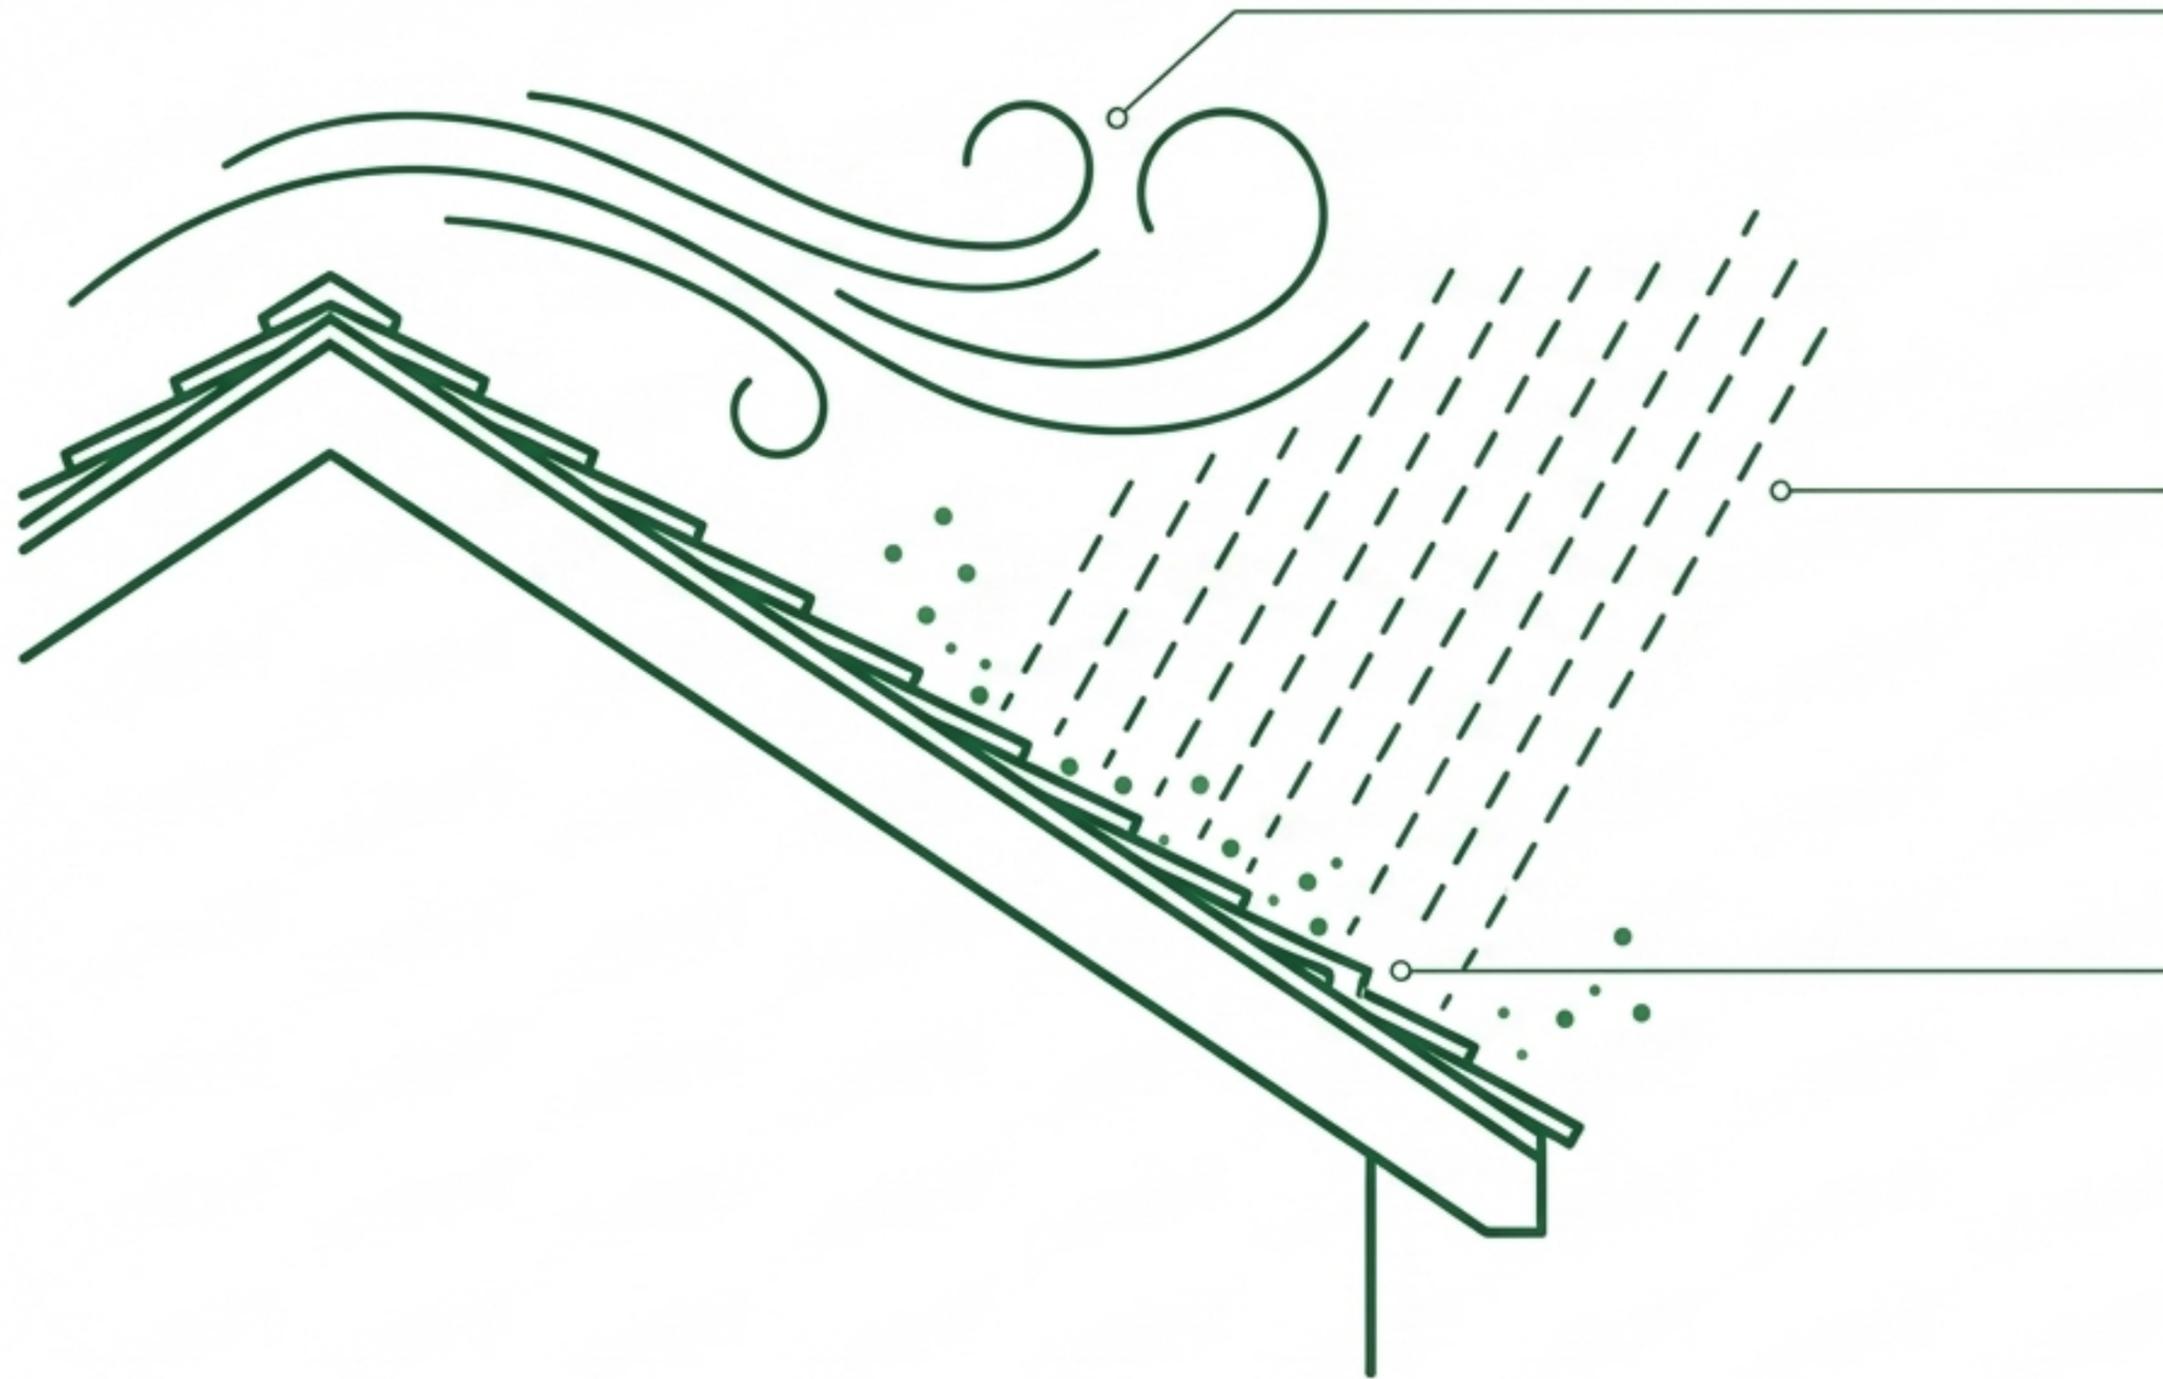
Environmental Stressors: Weather and Storms

Wind & Impact

High winds loosen granules at the leading edges, while heavy rain and hail physically dislodge embedded minerals upon impact.

Sustained Storm Events

Multi-hour storm events, such as regional Nor'easters, subject the roof to prolonged stress, severely accelerating natural shedding rates.

Freeze-Thaw Cycles

Winter freeze-thaw cycles allow water to expand in microscopic surface gaps, slowly pushing granules out over multiple seasons.

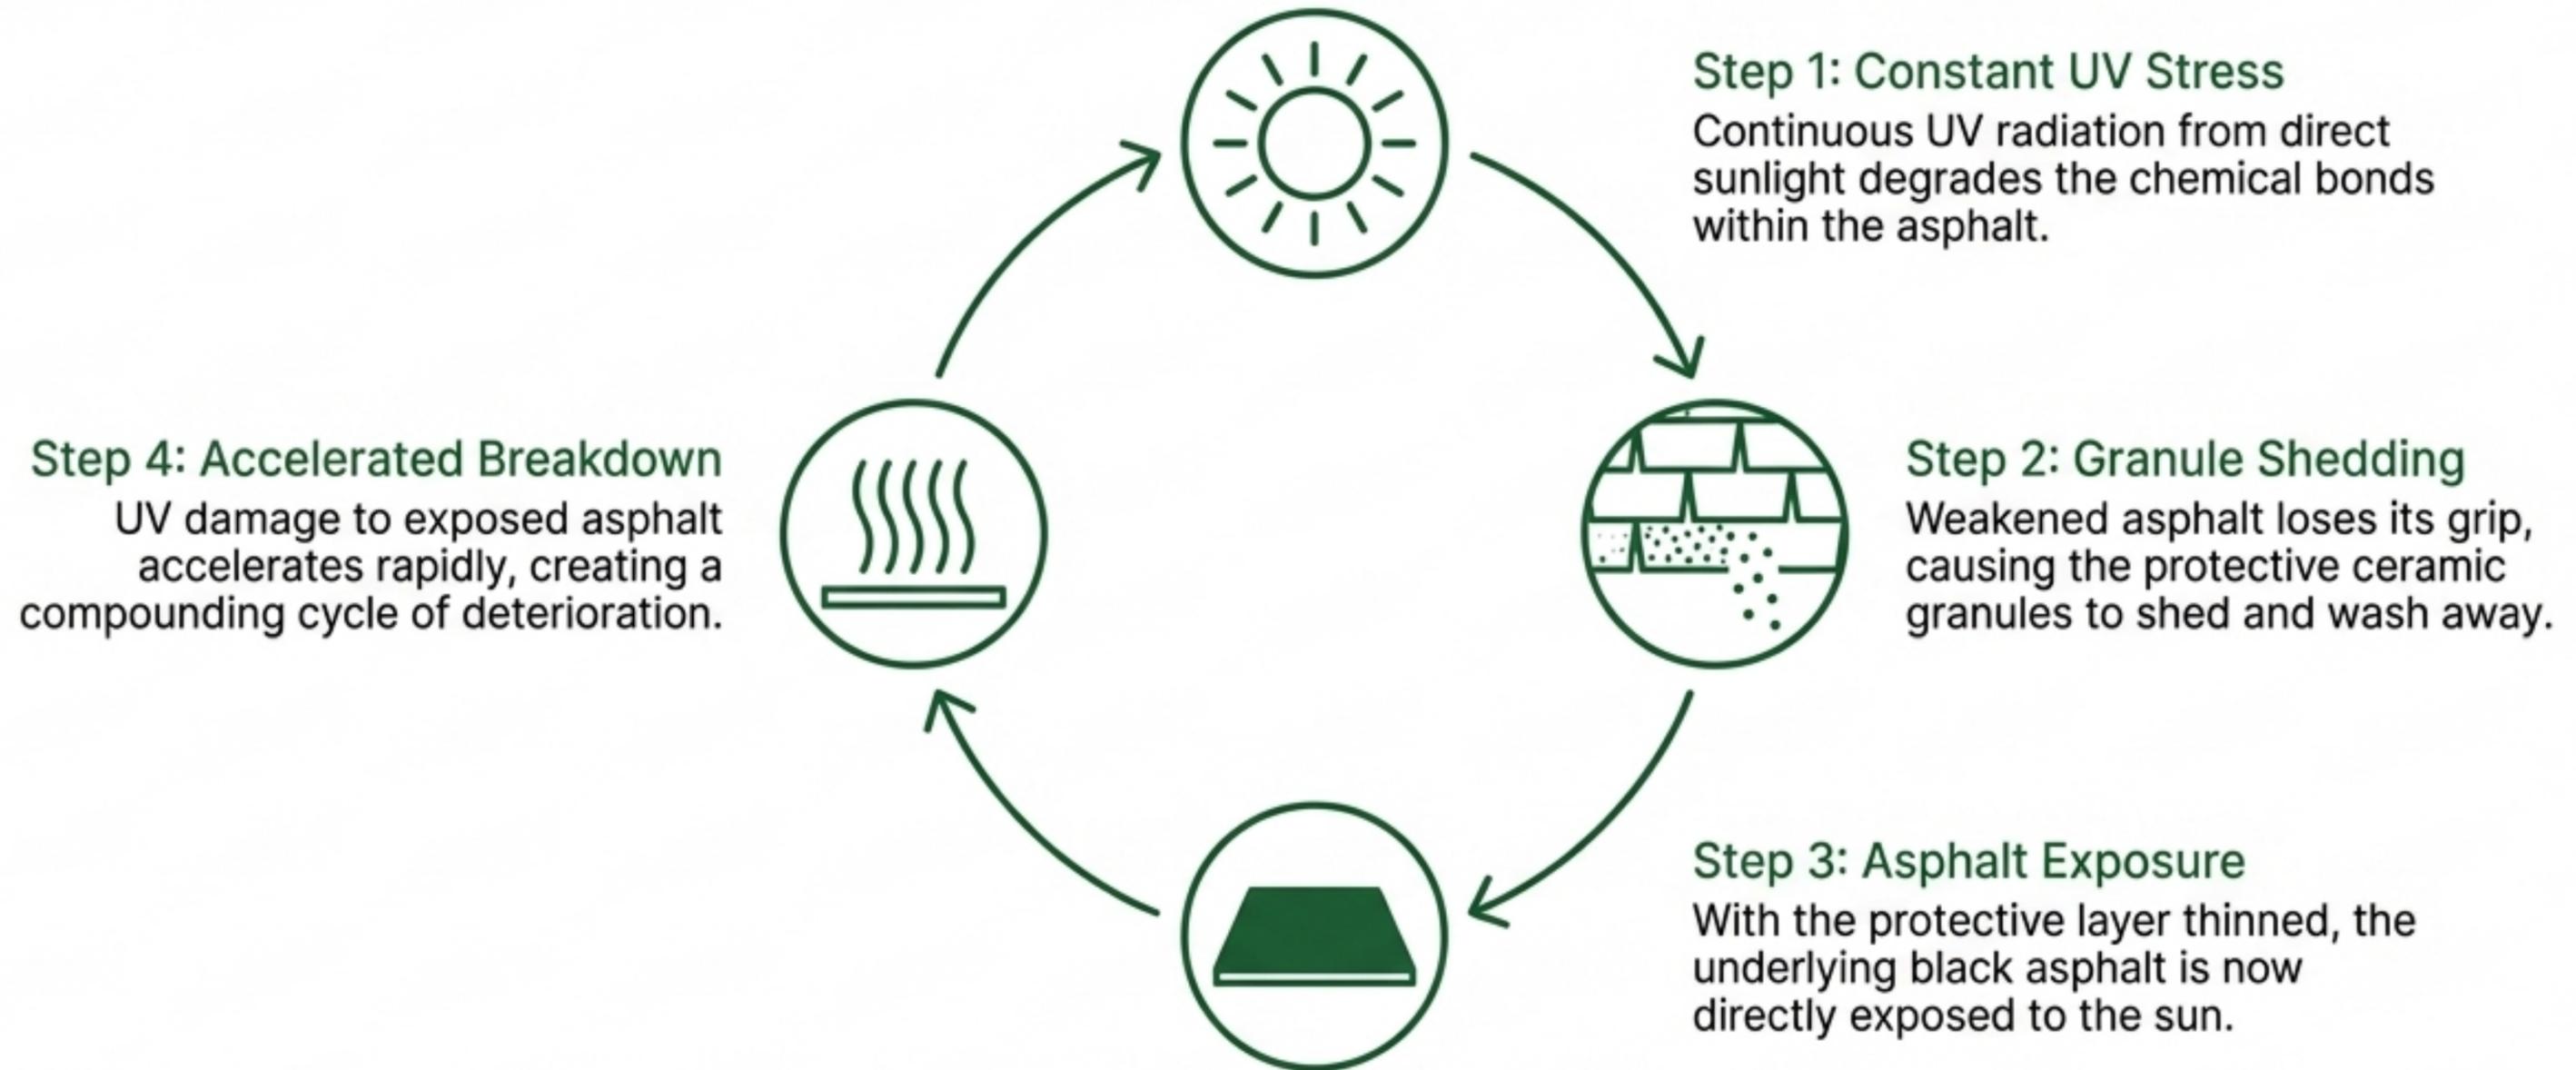
Environmental Stressors: The Cycle of Heat and Sunlight

Crucial Insight: South-facing roof sections typically exhibit faster granule loss due to significantly higher daily direct sunlight exposure.

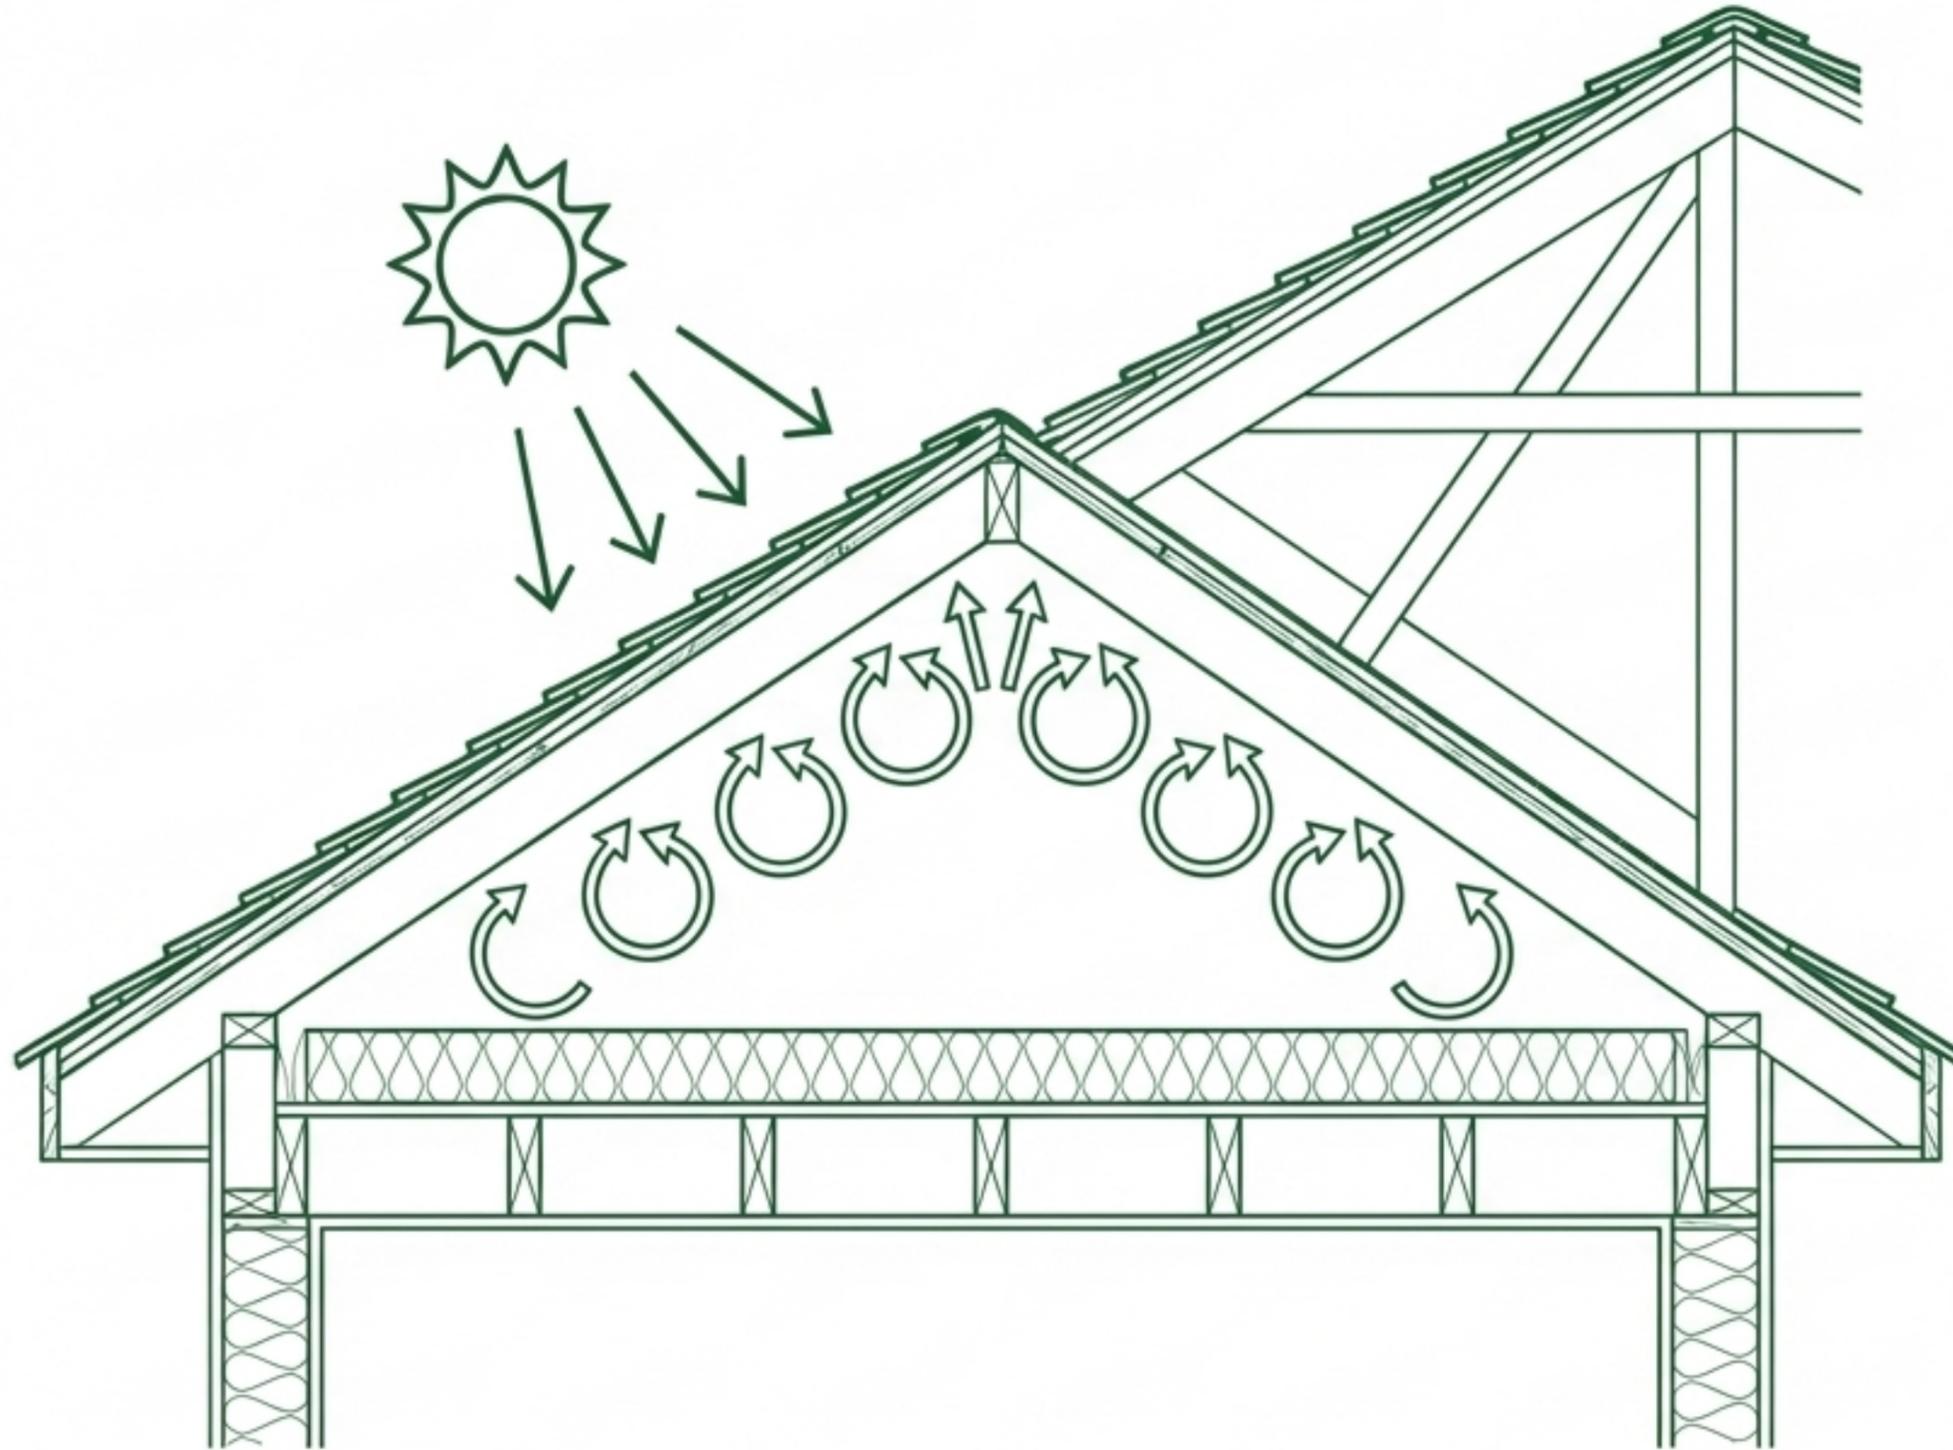
Systemic Stressors: The Impact of Poor Ventilation

Trapped Heat

Inadequate attic airflow traps excessive heat directly beneath the wooden roof deck during warm months.

The Baking Effect

This trapped, superheated air complements the sun's exterior radiation, effectively baking the shingles from the inside out.

Premature Embrittlement

Continuous overheating prematurely dries out the asphalt layer, destroying its ability to hold granules long before natural aging would.

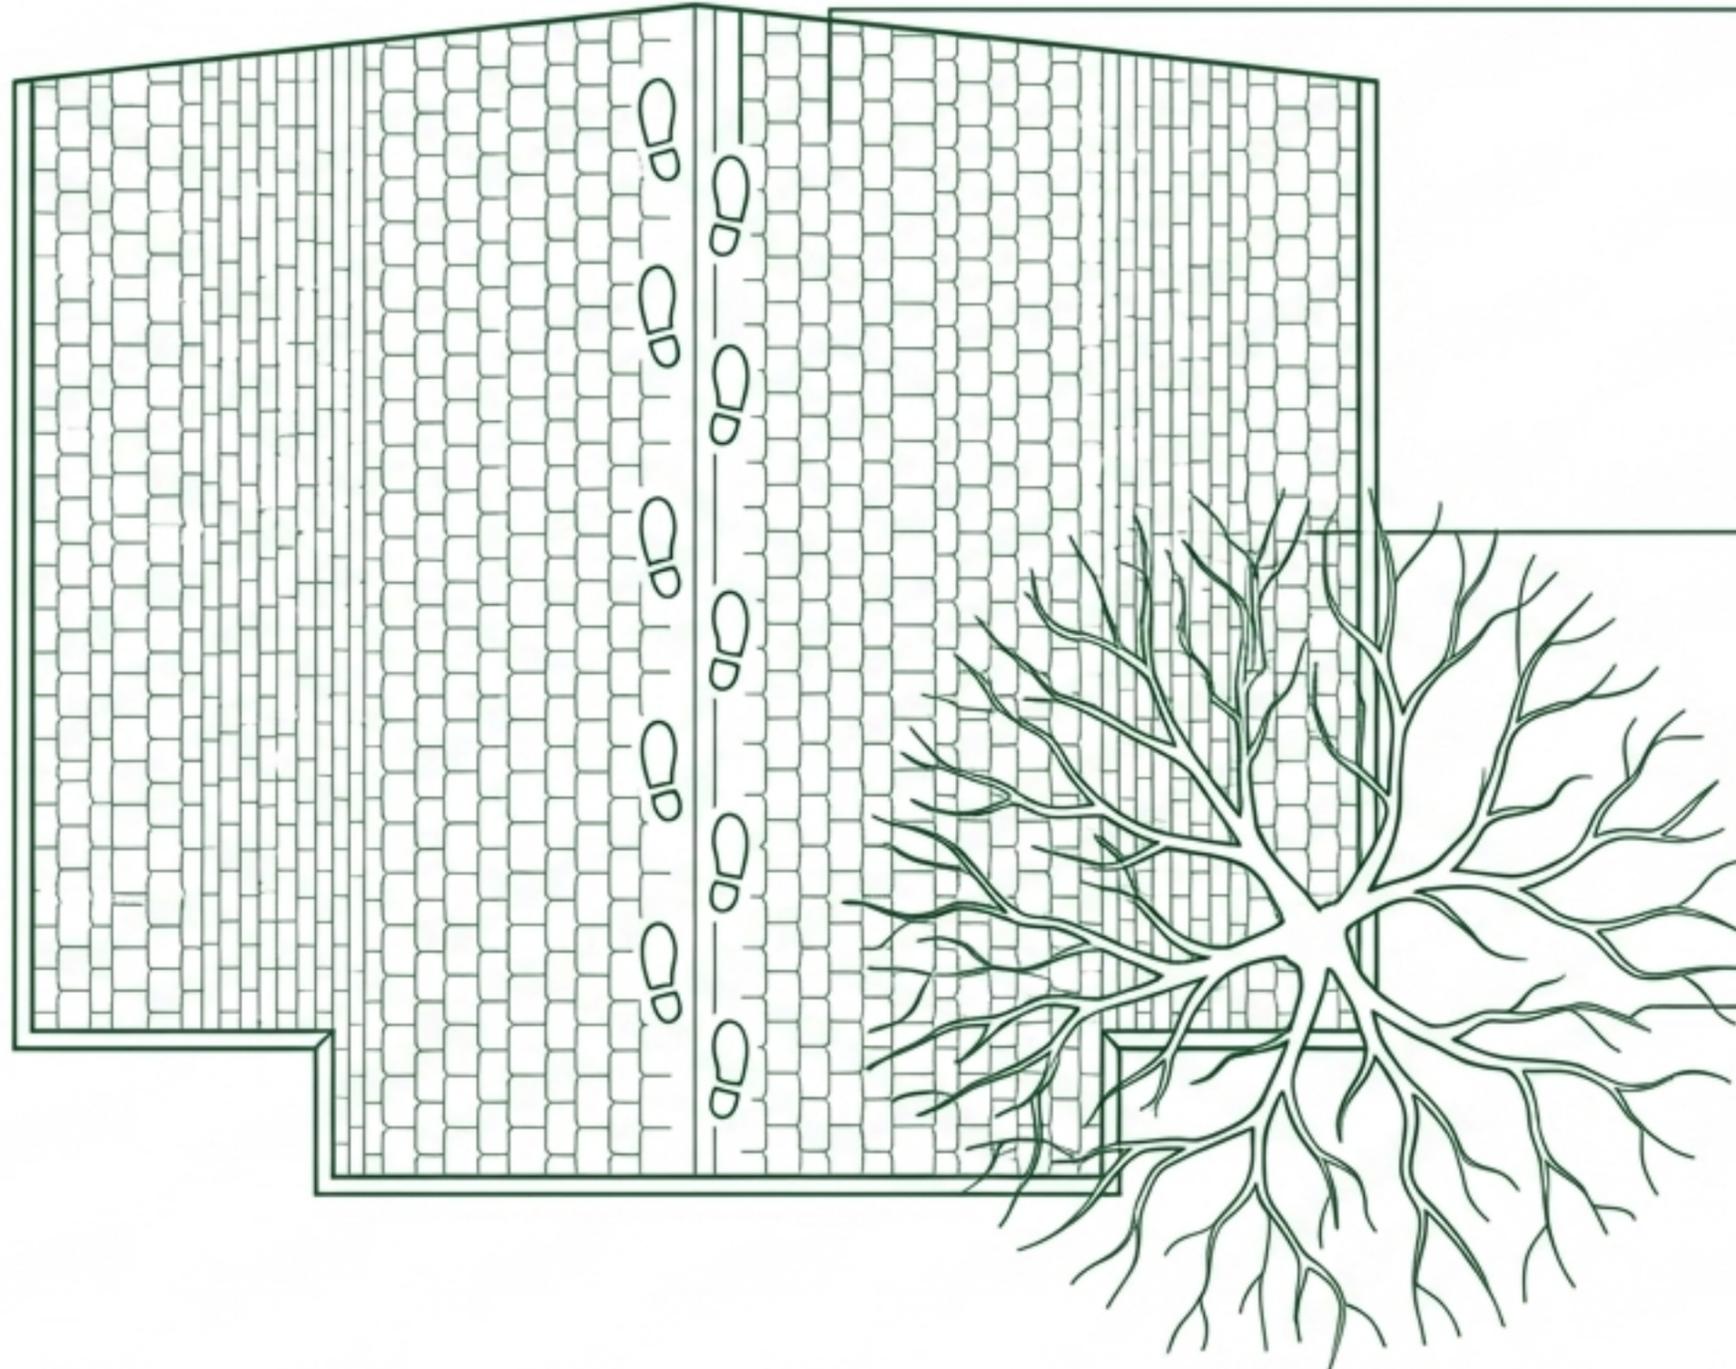
External Factors: Preventable Physical Damage

Foot Traffic

Walking on shingles breaks the fragile granule bonds at contact points, leaving distinctly worn paths, streaks, and permanent damage.

Overhanging Trees

Low branches brushing against the roof surface during wind events act like slow-moving sandpaper, actively scraping granules away.

Improper Maintenance

DIY cleaning methods or aggressive power washing immediately strip protective mineral layers and severely compromise roof integrity.

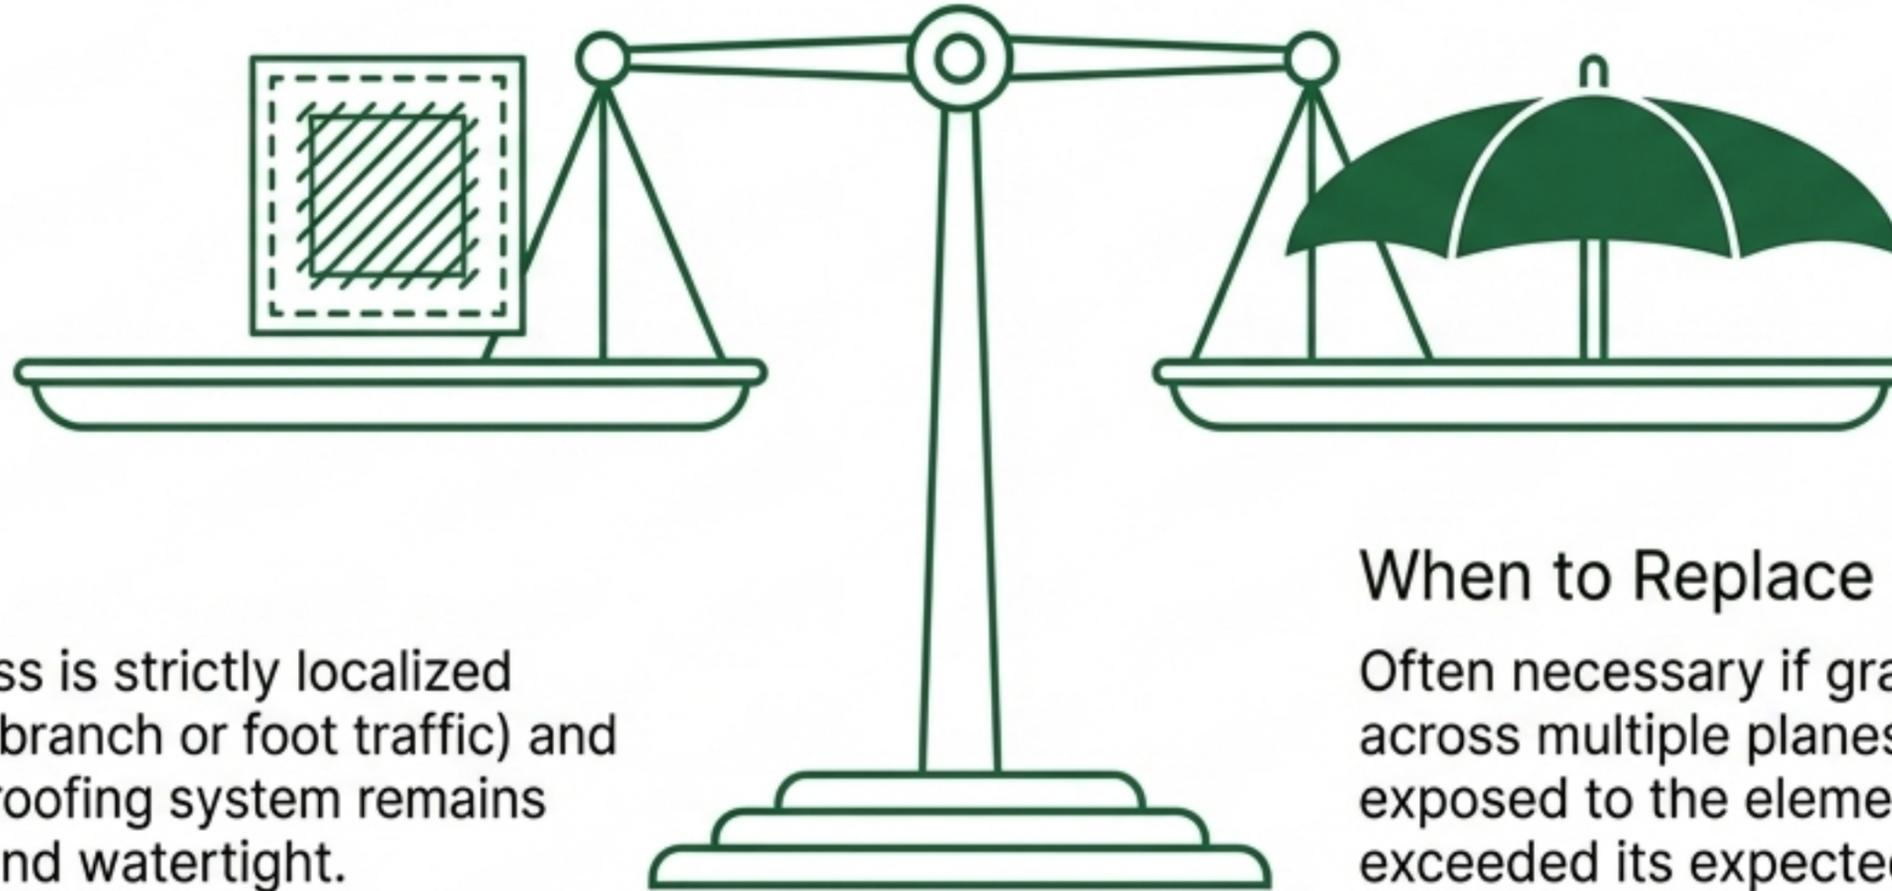
Decision Framework: Repair vs. Replacement

When to Repair

Viable if the granule loss is strictly localized (e.g., from a fallen tree branch or foot traffic) and the surrounding, older roofing system remains fundamentally sound and watertight.

When to Replace

Often necessary if granule loss is widespread across multiple planes, asphalt is widely exposed to the elements, and the roof has exceeded its expected timeline.

The Rule: Context—such as structural age, the precise extent of the loss, and ongoing weather exposure—determines the most objective path forward.
